Hobsons Bay City Council

Williamstown SLSC Pool

TECHNICAL REVIEW

JWC Engineers
JUNE 2018

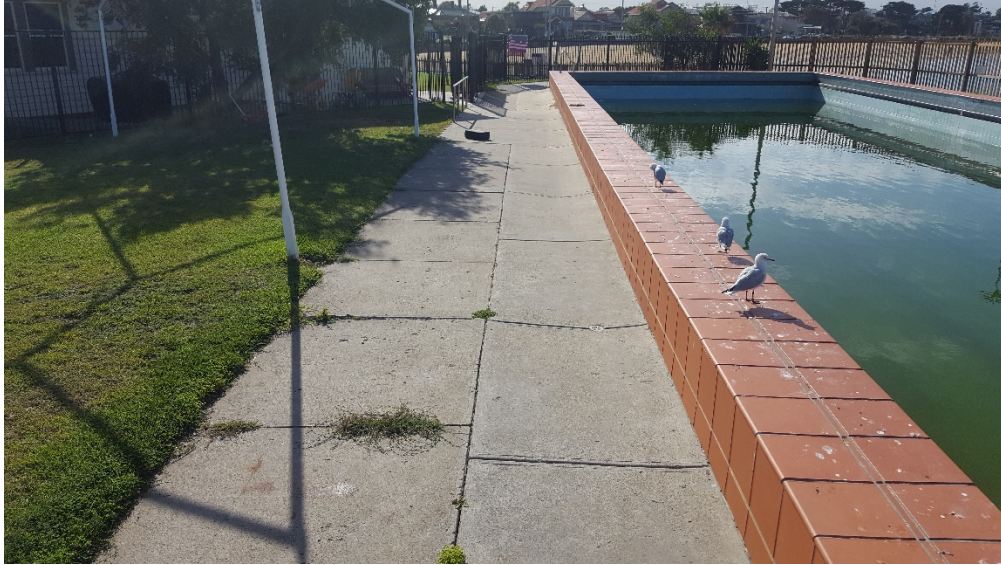
Image 7. Concourse on west side.

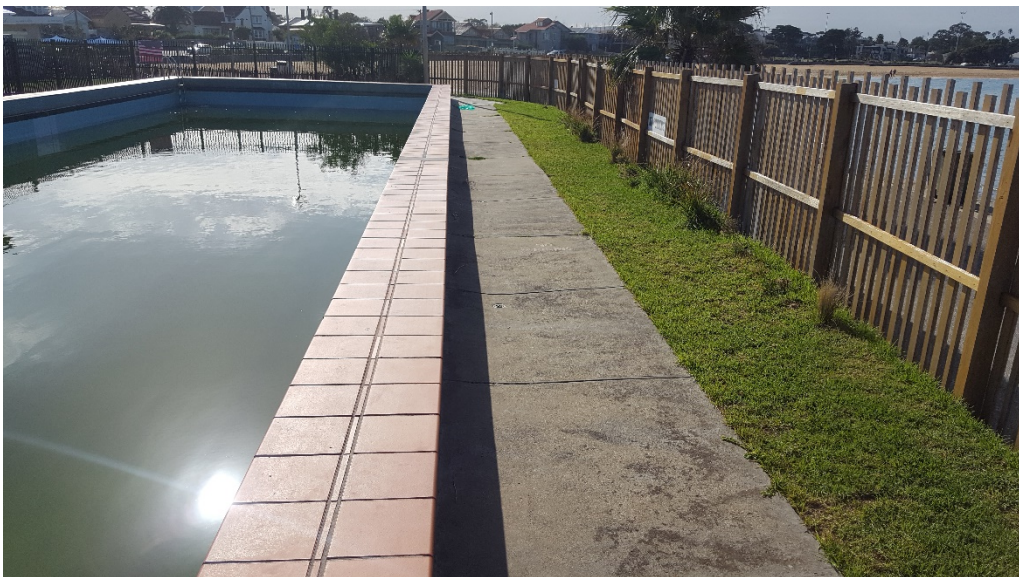
Image 8. Concourse on east side.

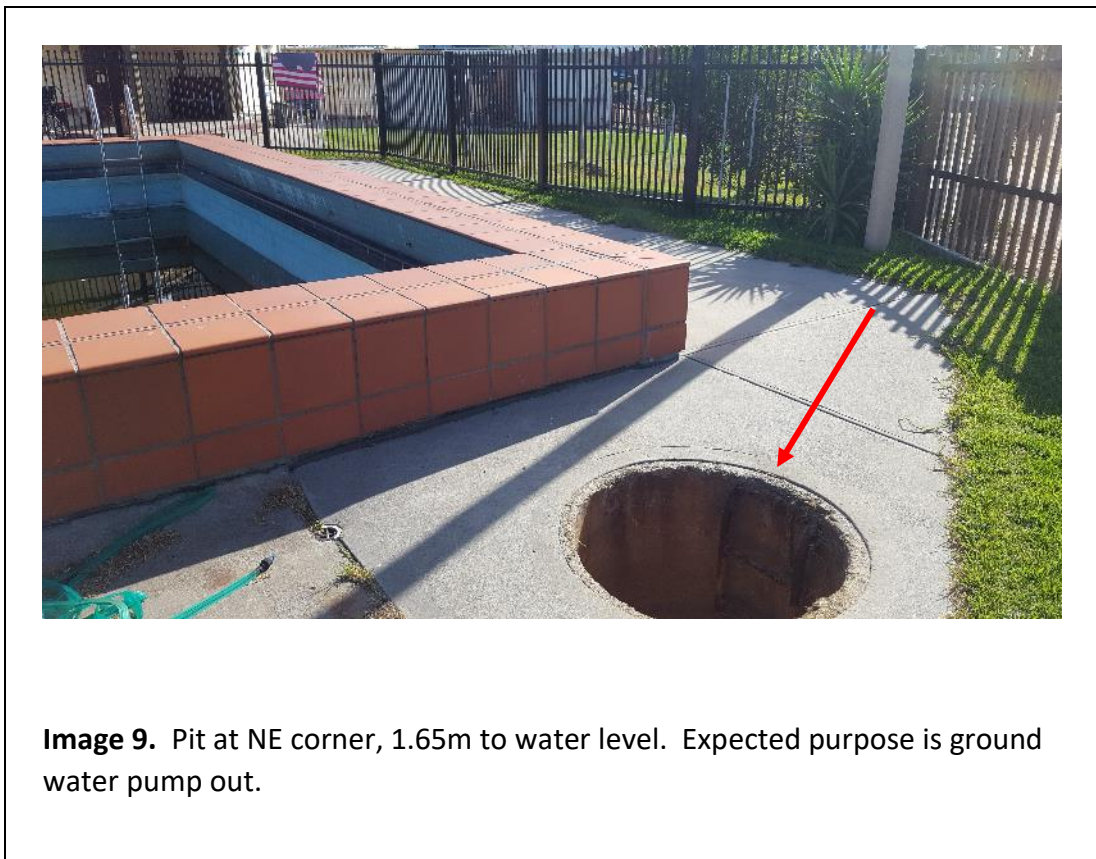
Further, the risk of uplift can be forecast to some extent from knowledge of the surrounding ground water levels relative to the pool floor at the deep end. The manhole in the NE corner (see **Image 9**) is expected to be for this purpose, that is:

The pit should be pumped down and cleaned out so that the base can be investigated for its functionality in this regard.

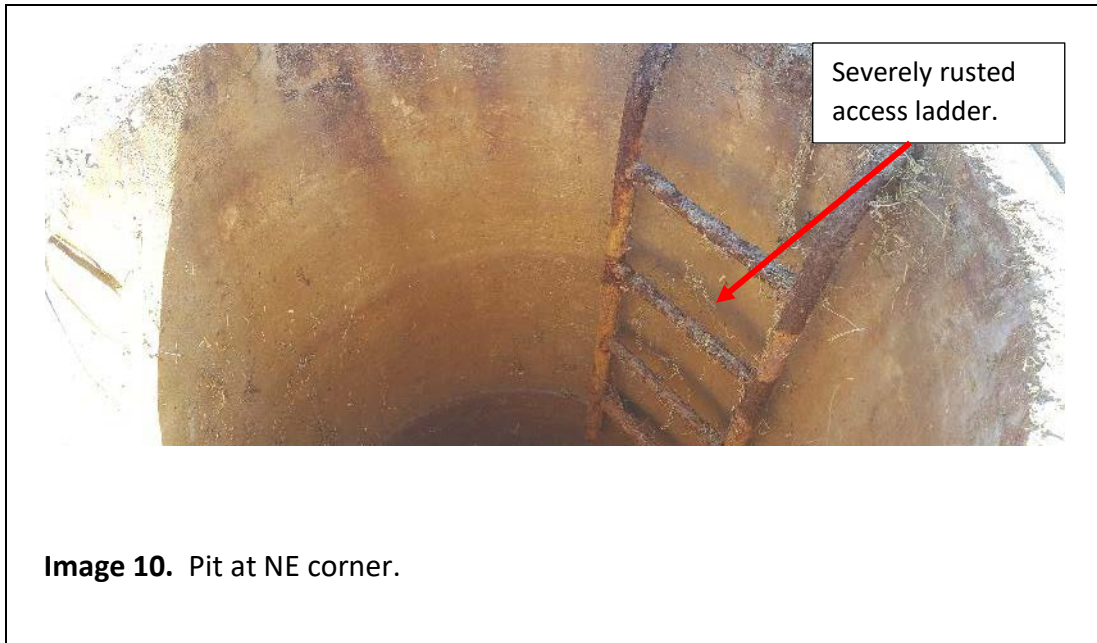
The access ladder is corroded and unserviceable, replacement is needed. See **Image 10**.

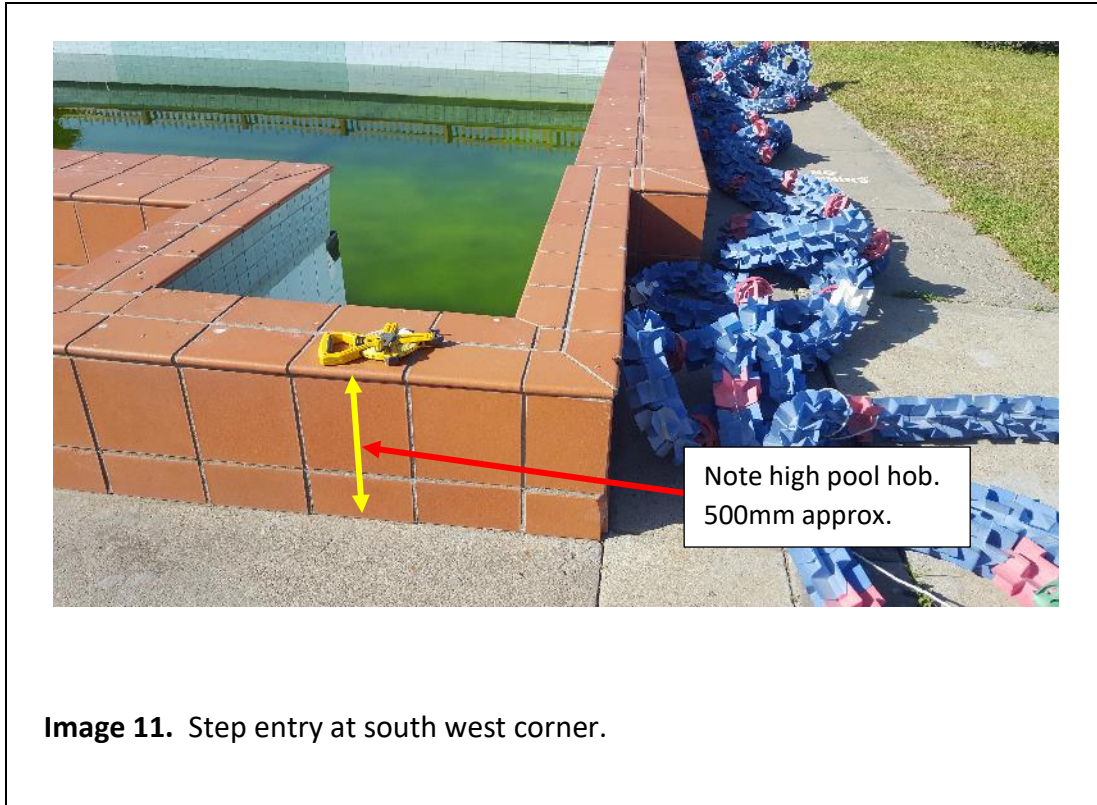
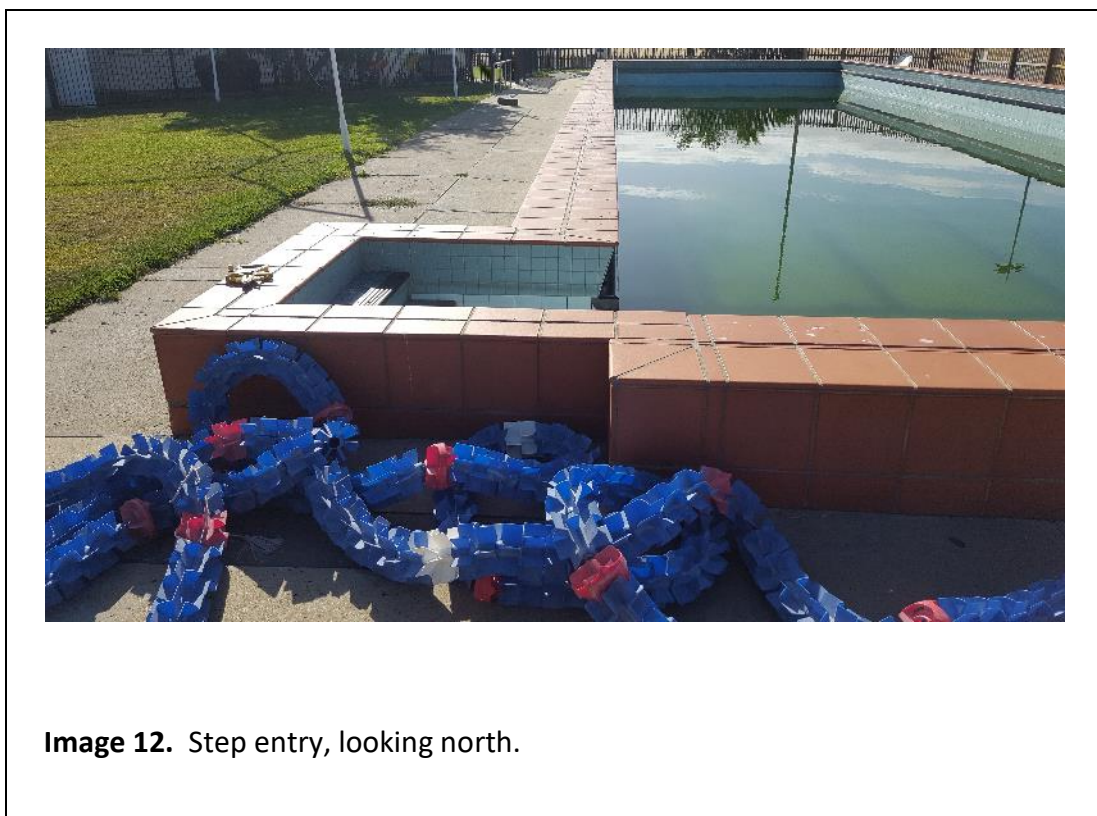
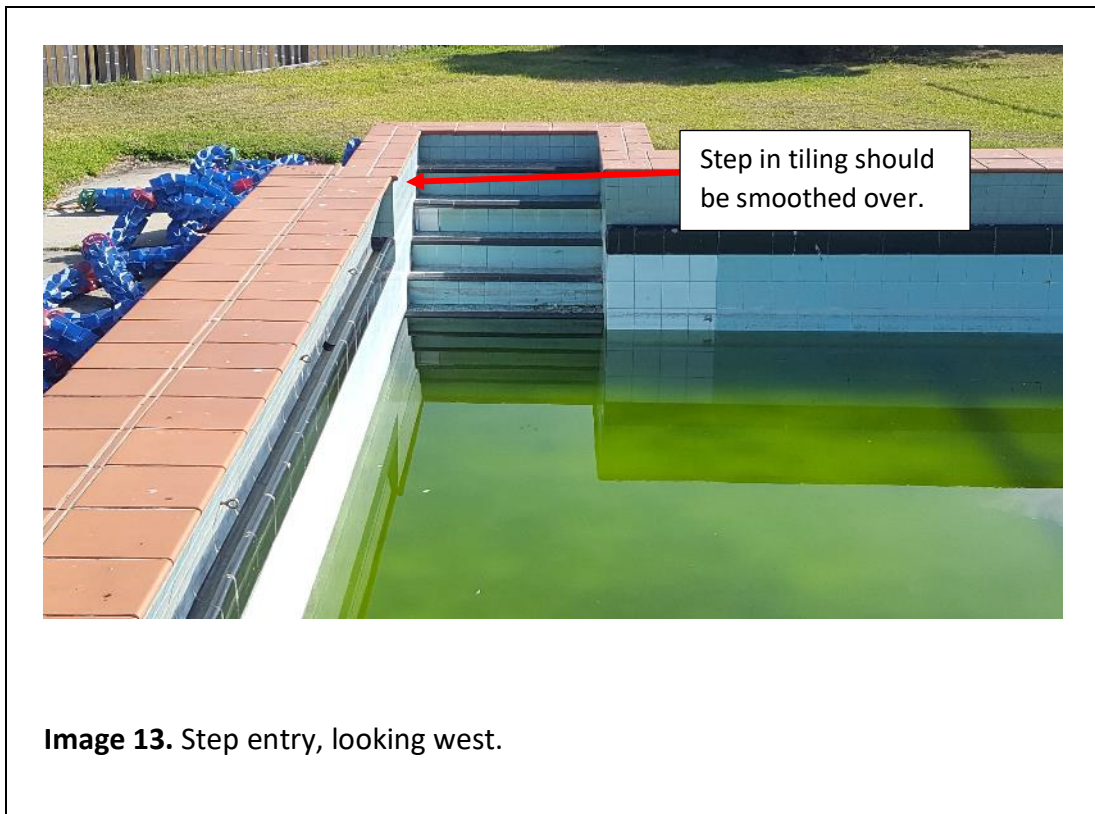
At the south west corner there is a step entry into the shallow end. See **Images 11, 12 & 13**. A horizontal offset (see **Image 13**) is a potential injury hazard and should be remedied.

The pool hob height is high at 500mm, and well above code compliant step heights which has a maximum of 225mm. Steps on the outside of the hob at both ladder and step entry are recommended. Some form of post, each side of the bottom step would be recommended to guard against the potential trip hazard.

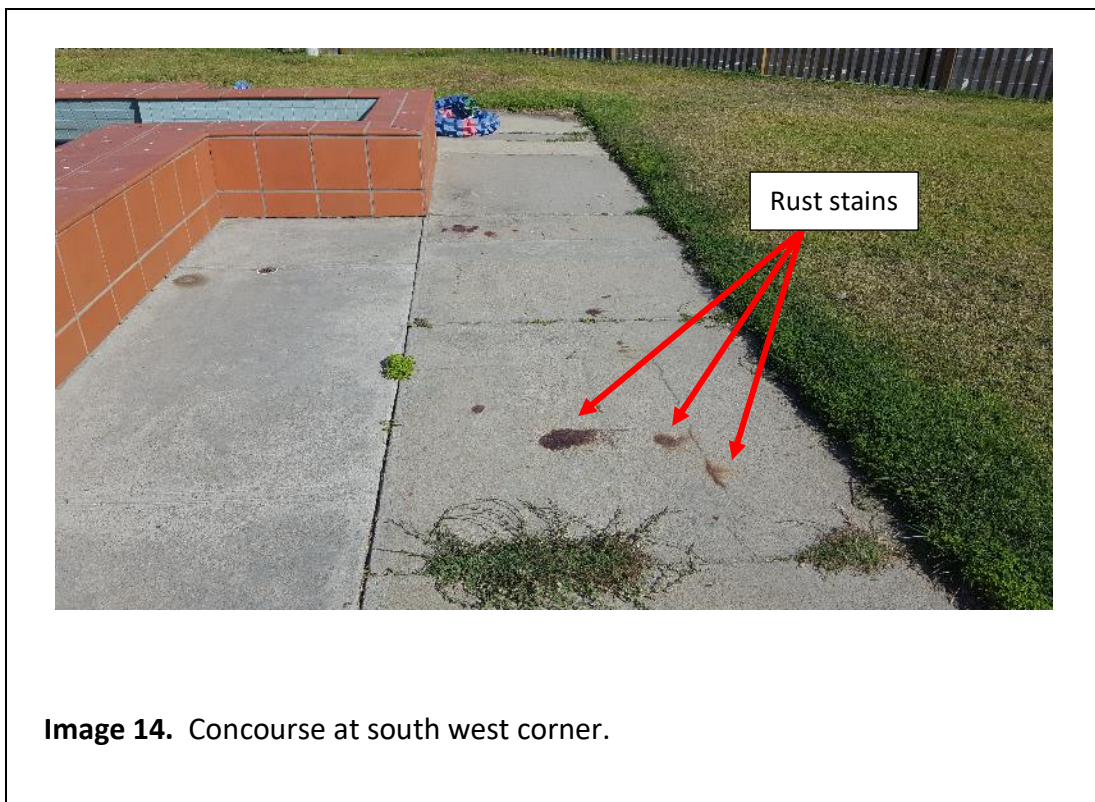
There are a number of small rust stains around the south west corner; these indicate corroding reinforcement and should be monitored for any delamination which will demand action. However, slab reinforcement is typically for shrinkage control only and the slab is usually not structurally reliant on it. See **Image 14**.

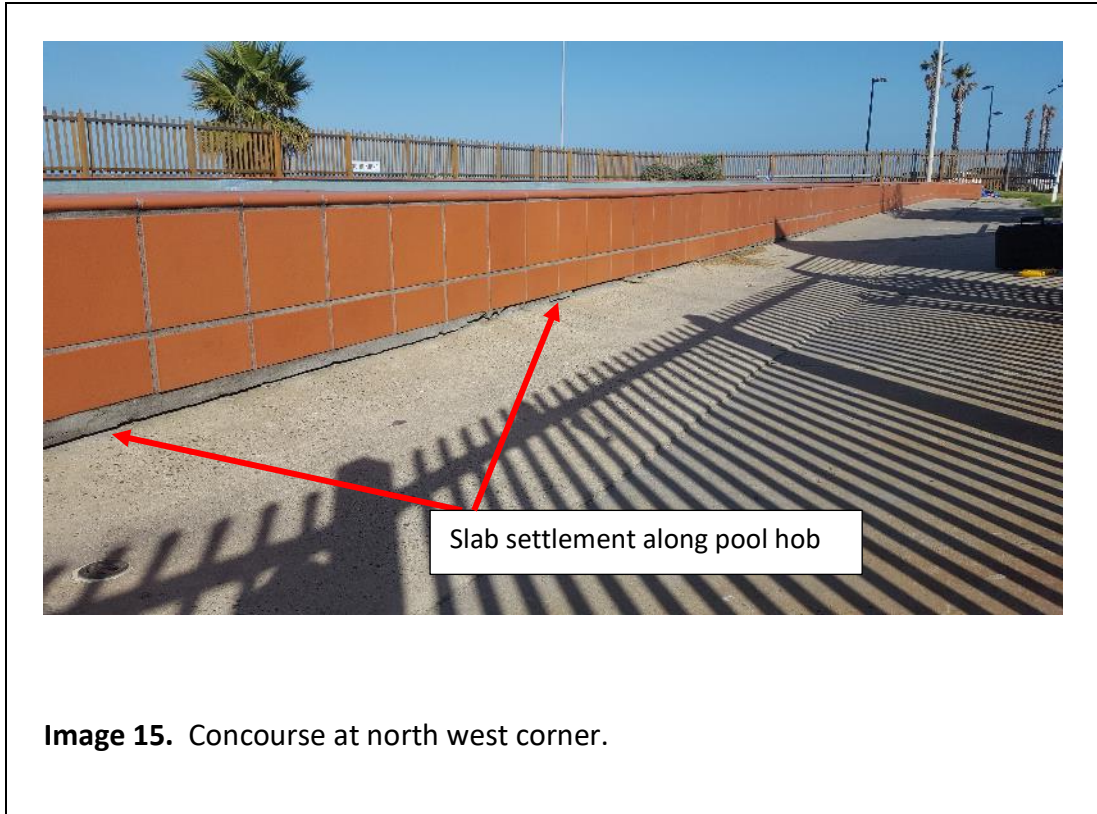
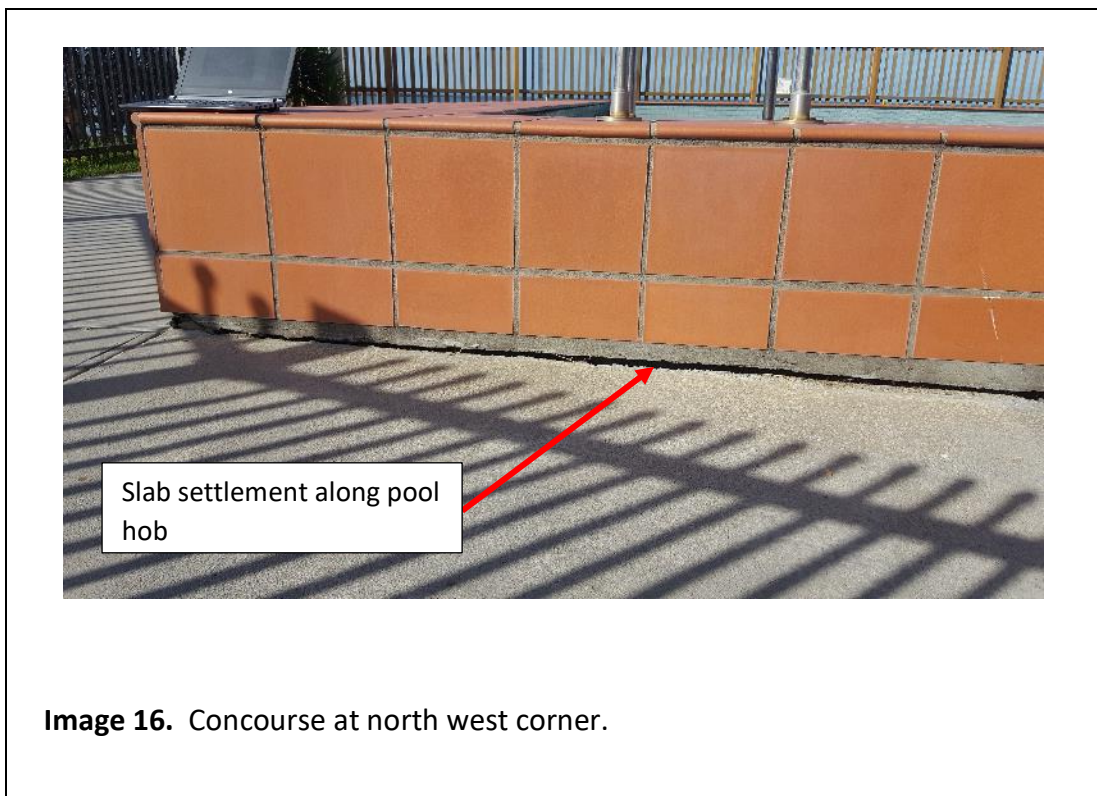
It is noticeable that some individual slabs around the northern end / sides of the pool have settled relative to the pool shell. Settlement is up to 1- 2cm. See **Image 15 & 16**.

This settlement does not appear to adversely impact the concourse in a material way and cosmetic repairs around the pool hob is all that is required at this stage.

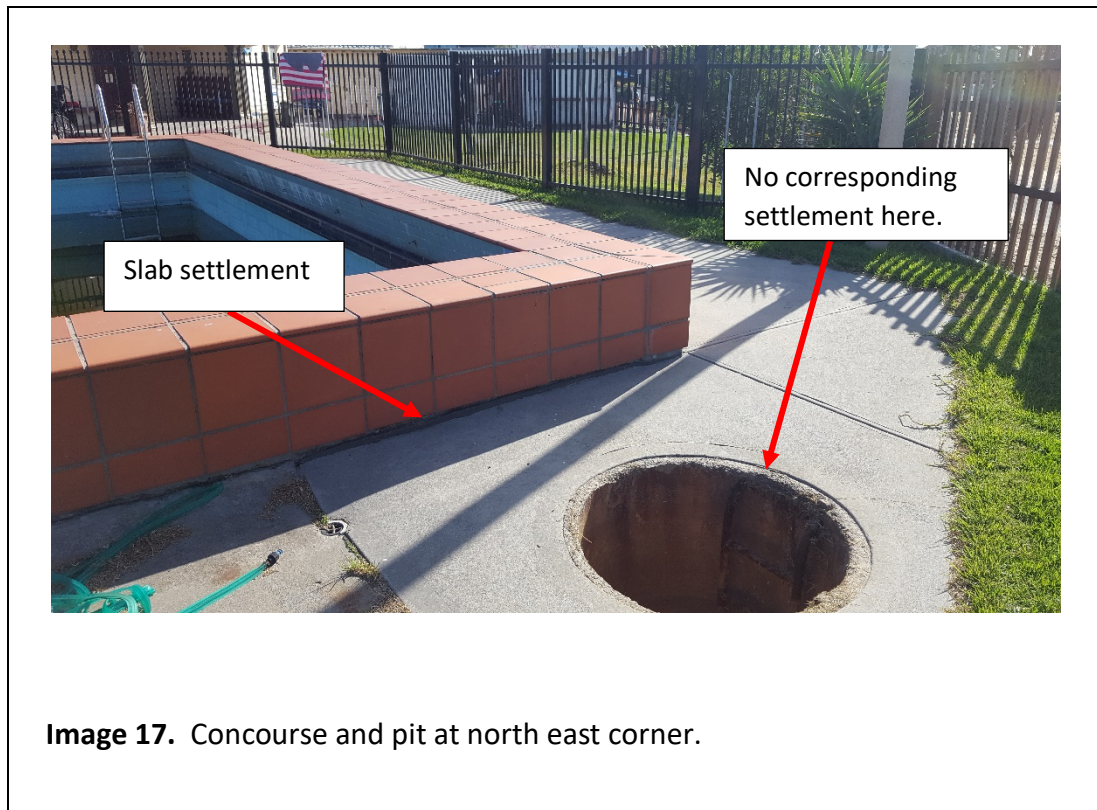
However, at the circular pit near the north east corner (see **Image 17**) the slab here looks relatively newer than others further south and has settled relative to the pool but not relative to the pit itself (which is deep at 1.65m to water level). This implies that there has been long term settlement of the pool backfill around this end of the pool, and to a depth that compasses the pit, and that this has driven some slab replacement at some point.

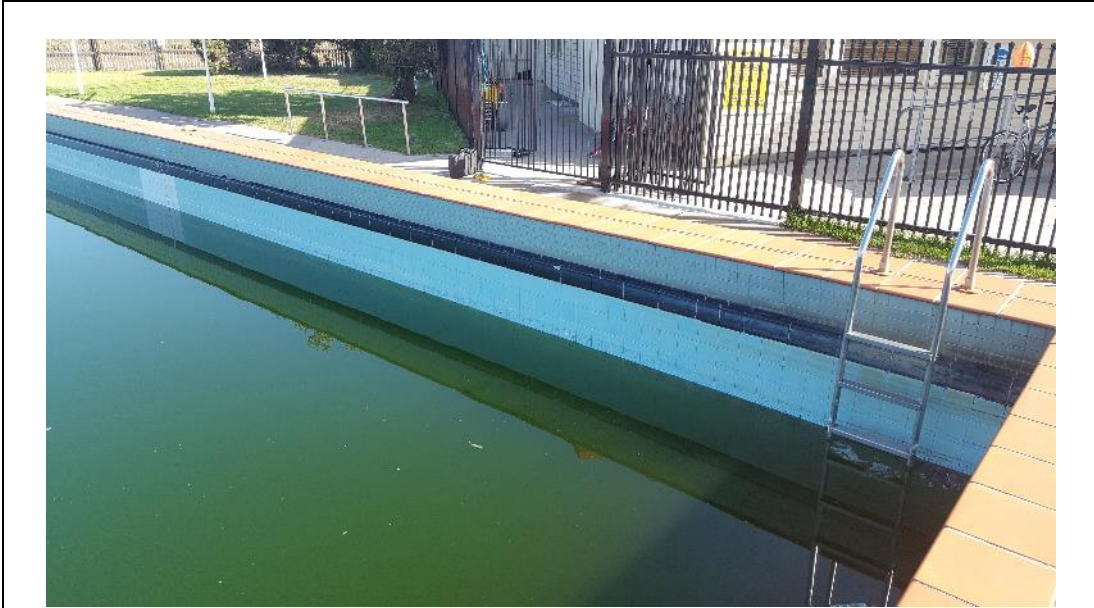
The bottom ends of the ladder were below water level and were not able to be seen. It is important that the bottom ends of the ladder are rounded and has no sharp protrusions that could be an injury hazard to swimmers; if so this should be rectified. See **Image 18**.

Image 18. North west corner of pool.

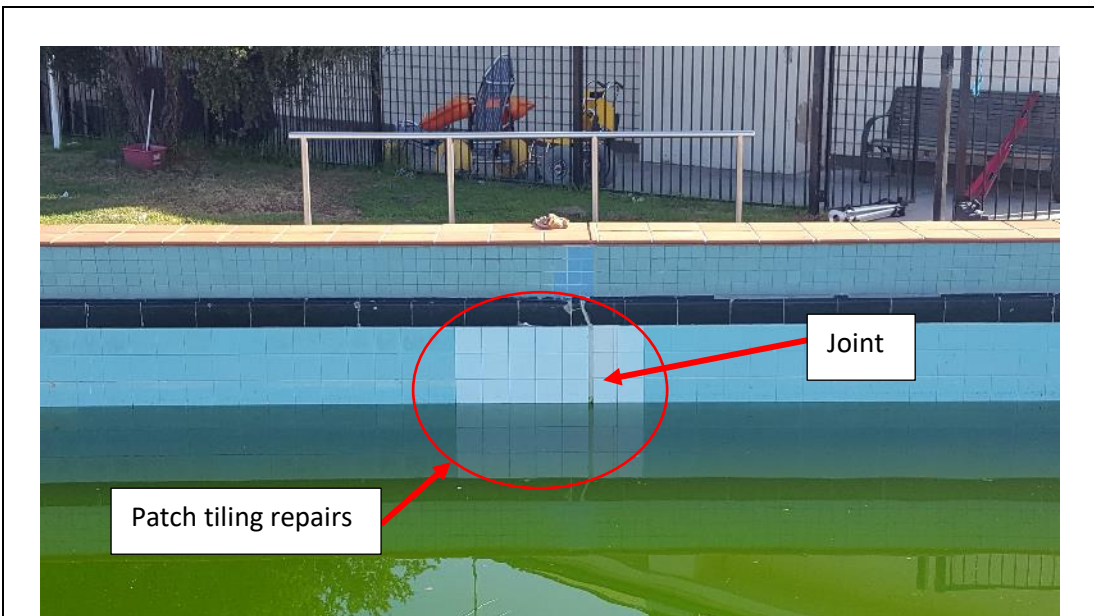
However, after many years of this approach, there are numerous patch repairs in the tiles themselves (especially the scum gutter tiles) and small areas of tile replacement, most predominantly at all four expansion joints.

Image 19. North west expansion joint.

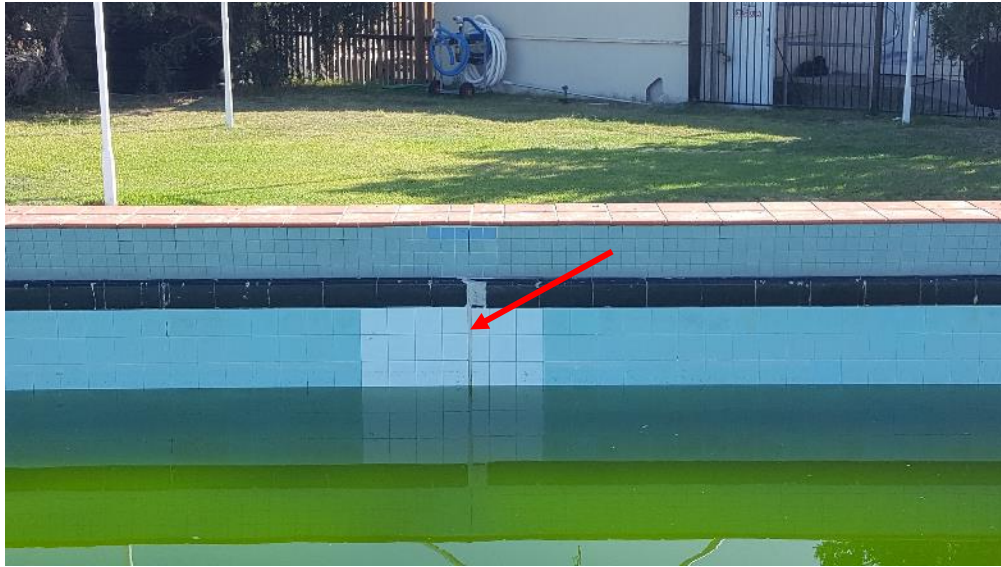
Image 20. South west expansion joint. Similar tiling repair as north west joint.

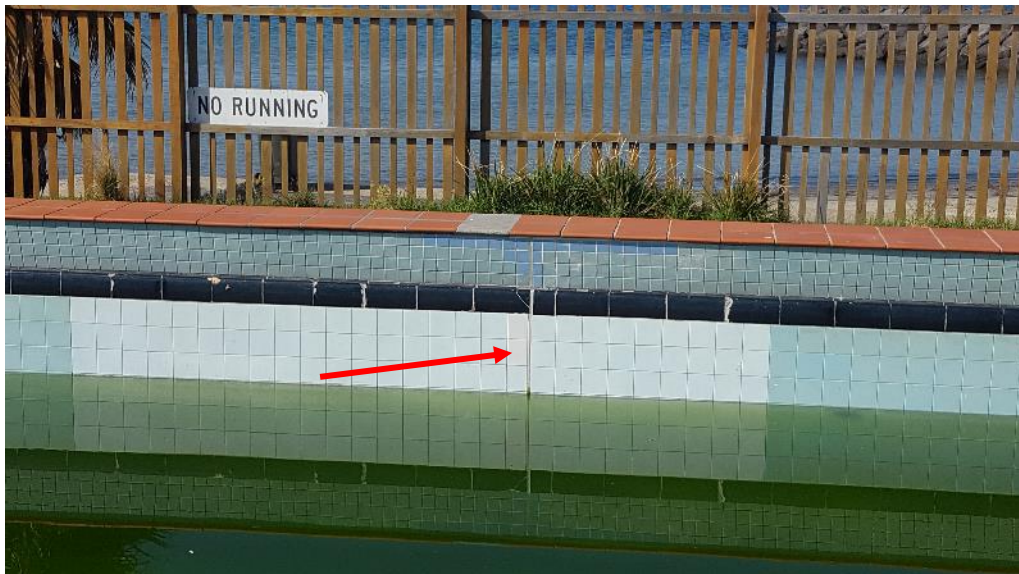
Image 21. North east expansion joint.

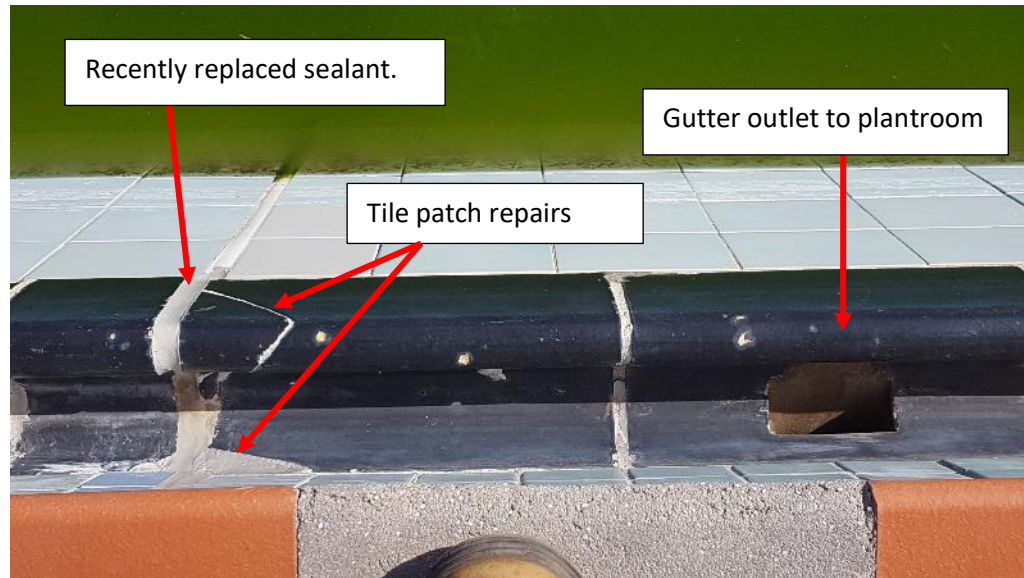
Soiled water is collected by scum gutter tiles around the full perimeter. The gutter drains to outlets, 100 x 50mm, and there are 7 along each side and 2 at each end, giving 18 in total. See **Image 22**. While this scum gutter tile configuration is consistent with the importance of a continuous skimming system around the perimeter, their hydraulic capacity is limited by the gutter size and is considerably less than current day systems.

Image 22. North east expansion joint. View looking down.
