# **Engineering Investigation Report**

| FMG REF: | S37718 - 258126 |
| SITE ADDRESS: | 100 Esplanade, WILLIAMSTOWN, VIC 3016 |
| CLIENT: | Hobsons Bay City Council |

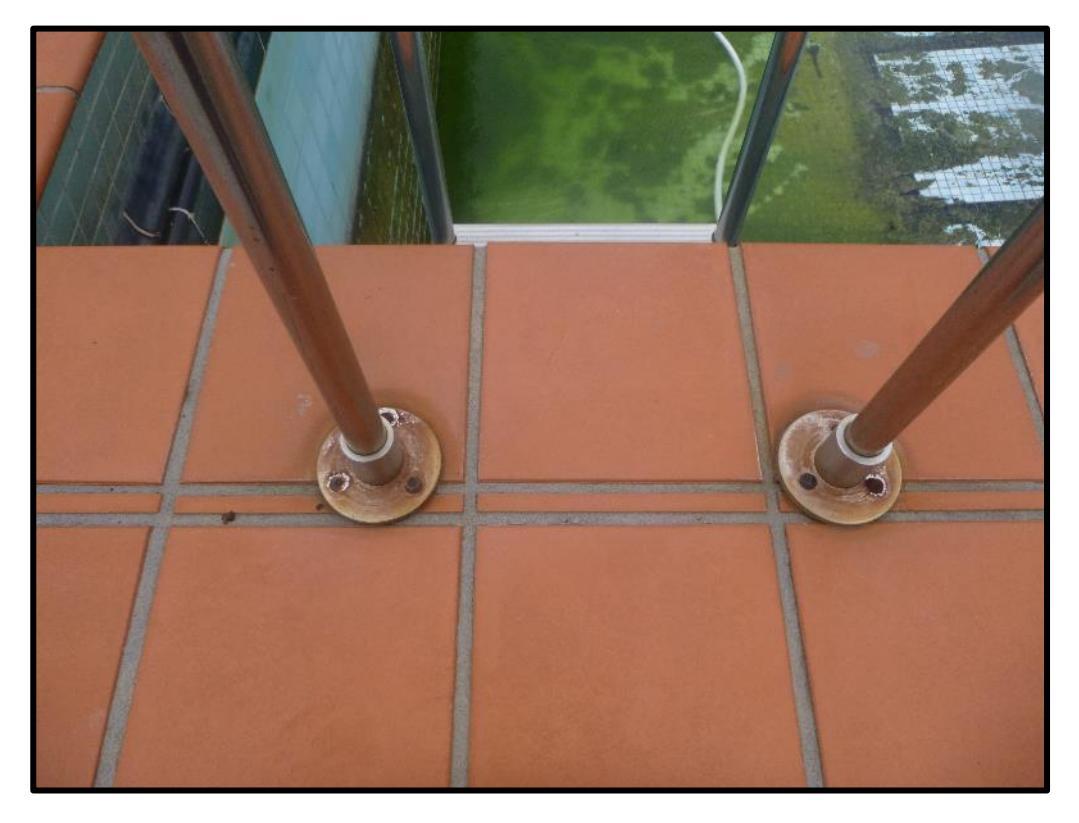
- Slight corrosion of ladder fixings (located towards the north-west corner of the pool) [2].
  - Coping beam tiles have delaminated [3, 4, 6]
  - Concourse drain near northern control joint, western end. Overflowing with sand when flow was reversed due to emptying the pool. [5]

Photograph 2 - Slight corrosion of ladder fixings (north-west corner)

- (6) The stainless-steel items should be maintained using appropriate products. The lane rope anchors and ladder fixings will likely require replacement in the next three years.
- 4.16 Improvements to the pool could also be undertaken such as modifying the pool to include a wet-deck instead of a scum gutter or even simply a shorter hob. This will improve visibility of the pool for life guards or parents supervising children. A renovation system such as the 'Myrtha RenovAction' may also be suitable for this pool.

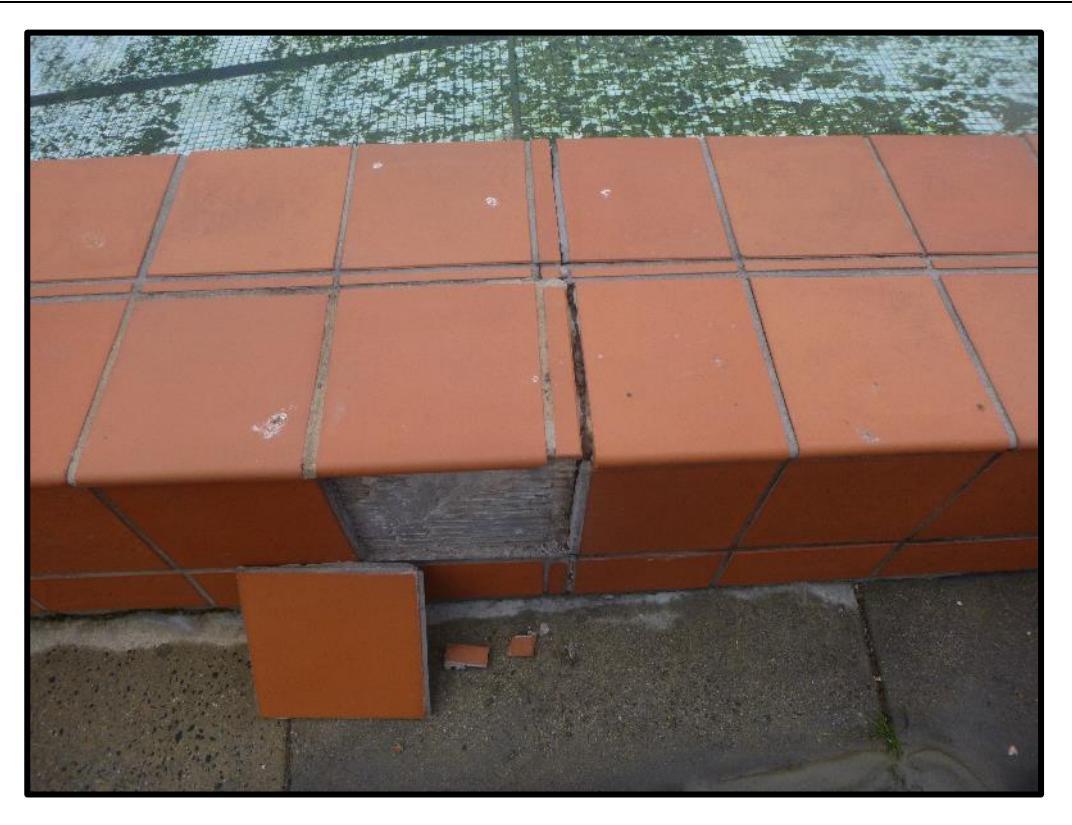
Photograph 3 – Northern control joint, western end. Coping beam tiles have delaminated.

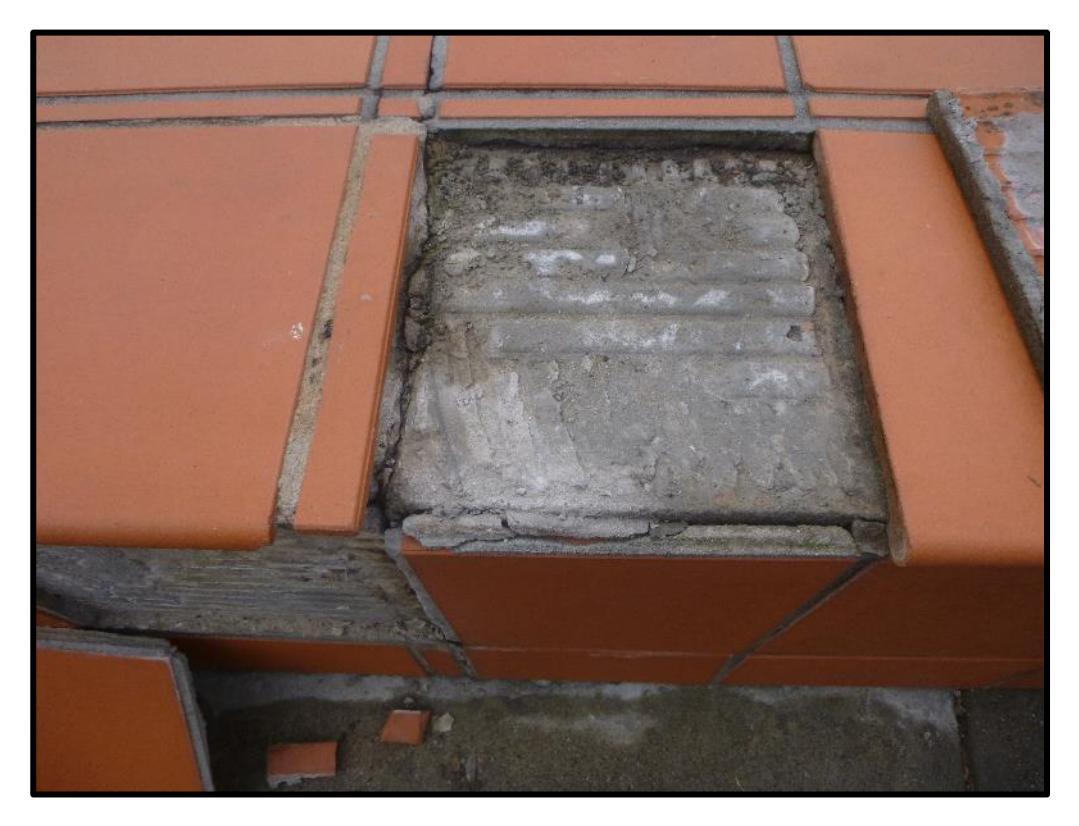
Photograph 4 - North-west control joint. Coping beam tiles have delaminated

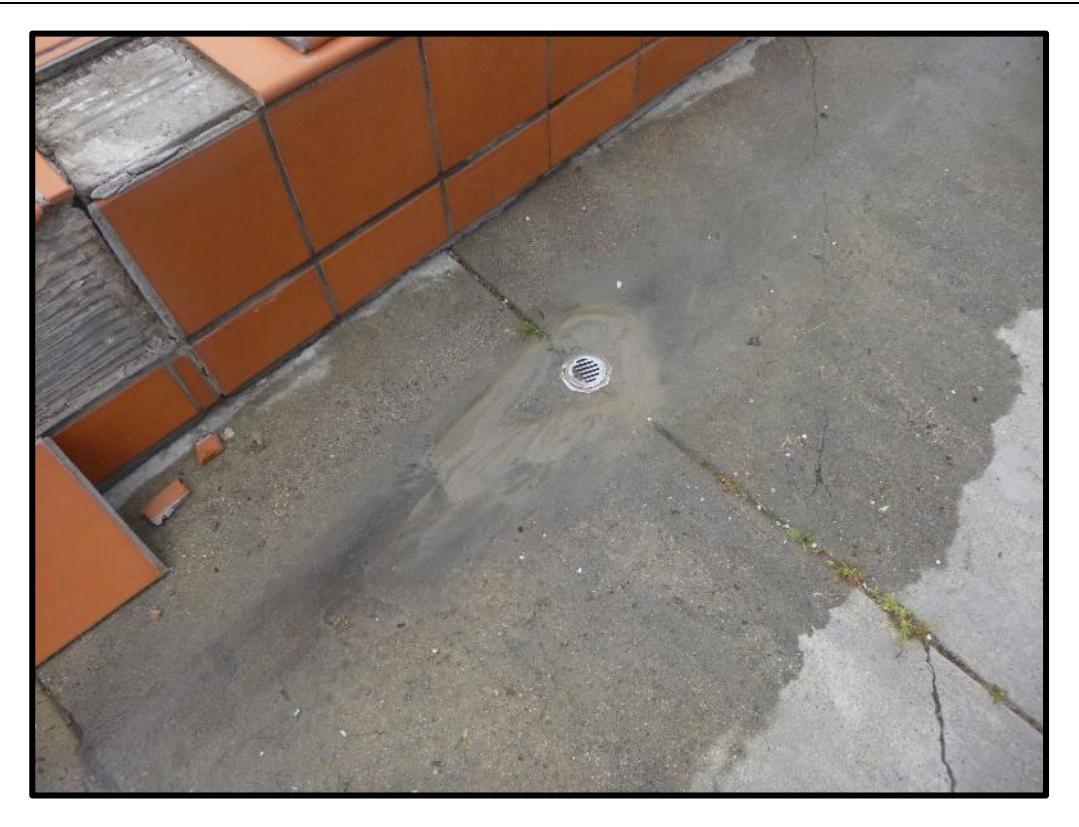
Photograph 5 – Concourse drain near northern control joint, western end. Overflowing with sand when flow was reversed due to emptying the pool.

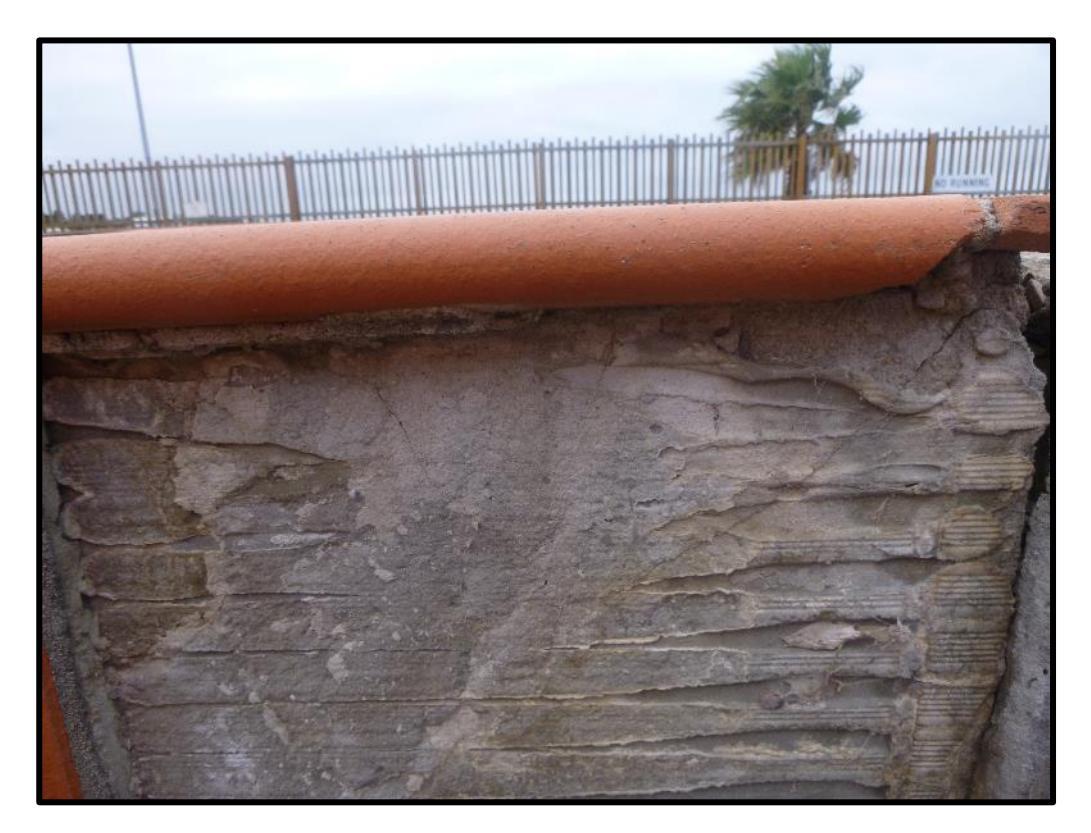
Photograph 6 - North-west control joint. Coping beam tiles have delaminated

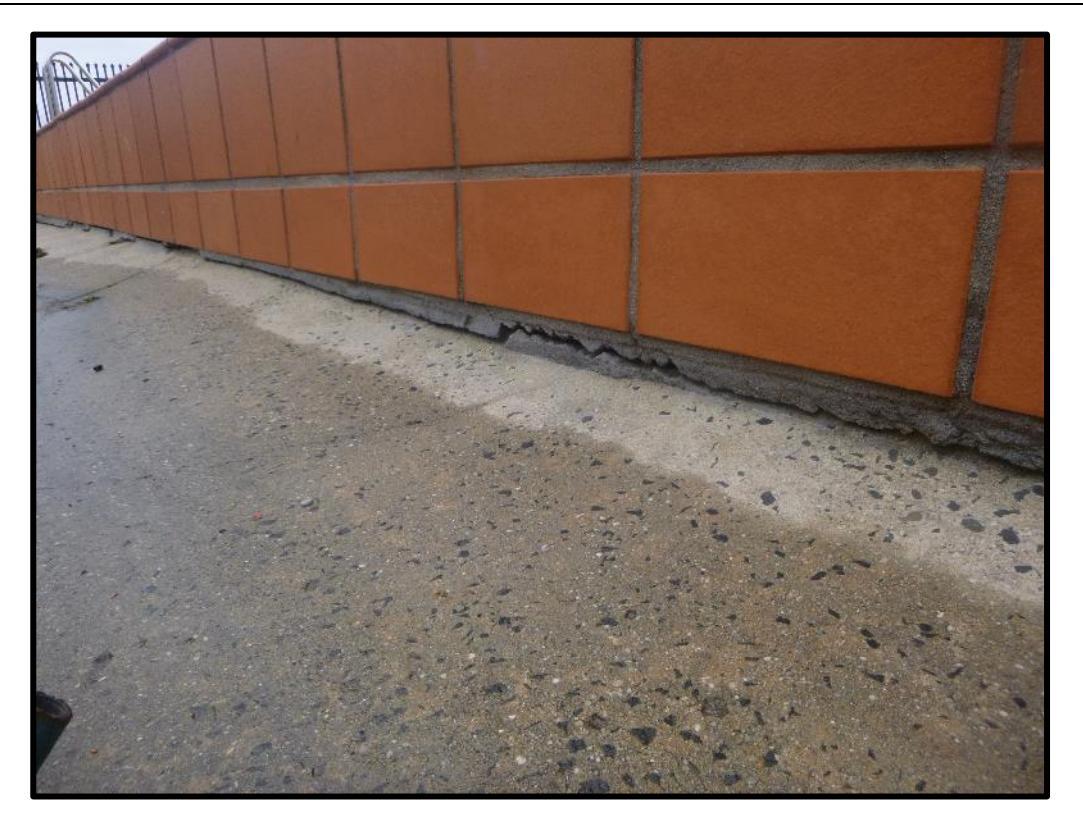
- Crack between the render/tiles and the concourse. Western side of the pool, towards the northern end of the pool. [7]
  - Approximately 45mm of render and tile overhangs the concourse [8].

Photograph 7 – Crack between the render/tiles and the concourse. Western side of the pool, towards the northern end of the pool.

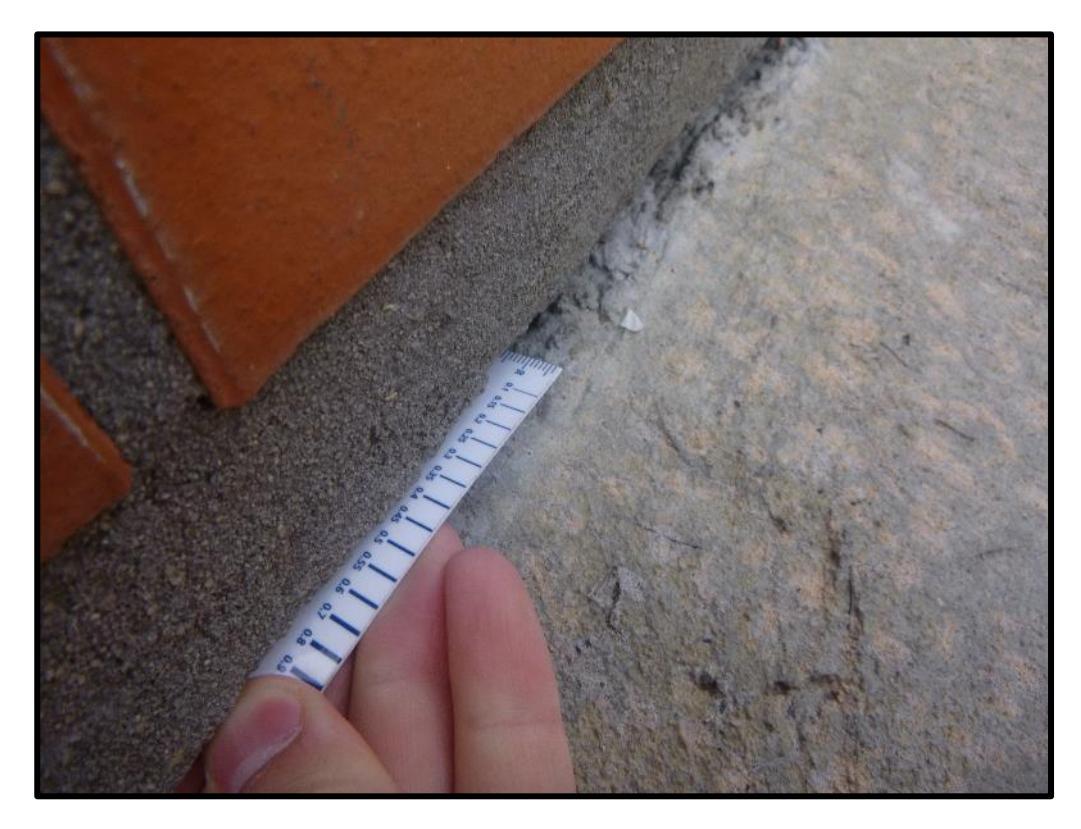
Photograph 8 – Approximately 45mm of render and tile overhangs the concourse

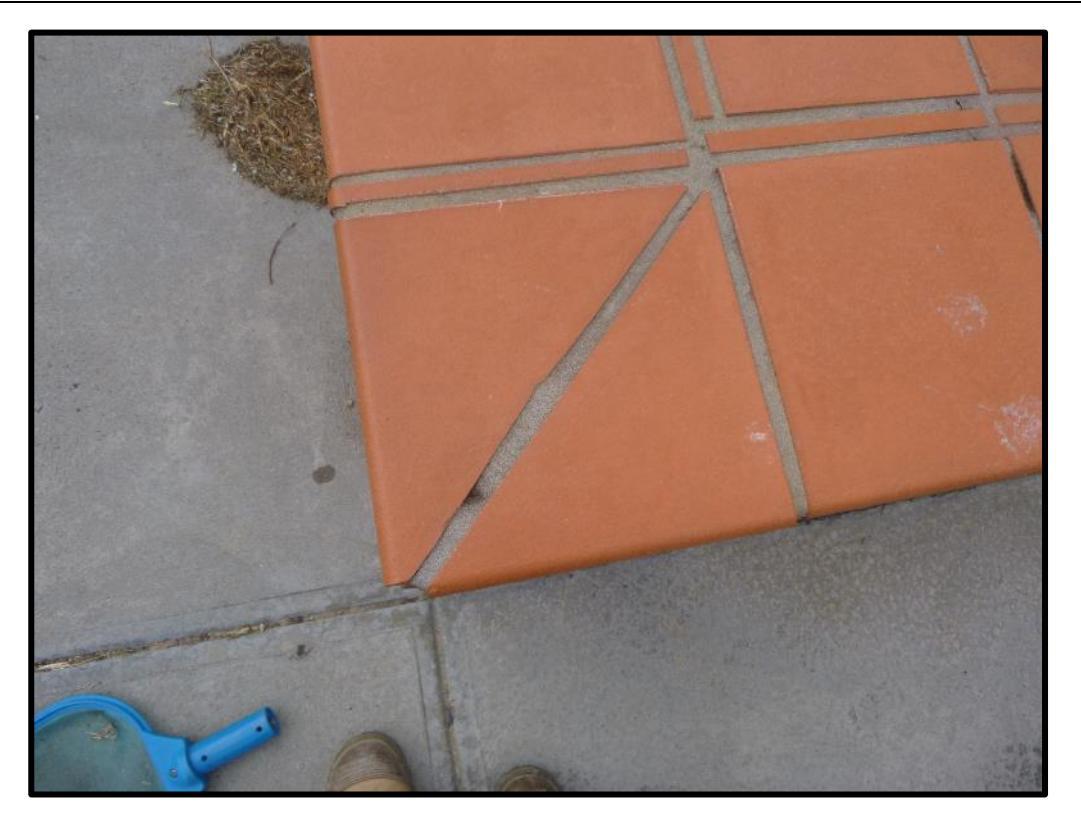
Photograph 9 – North-west corner of pool. Corner of the pool is relatively acute.

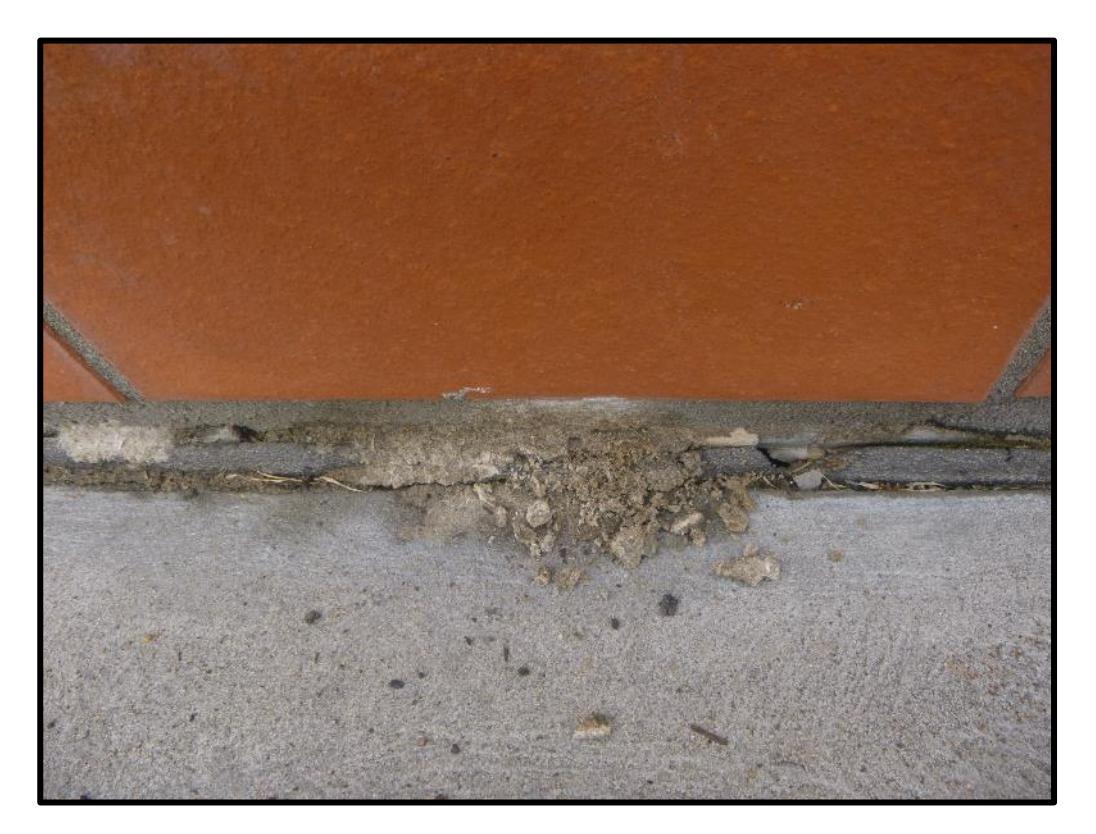
Photograph 10 – Compressible foam between new section of concourse and pool along northern end of pool. Calcium build up evident.

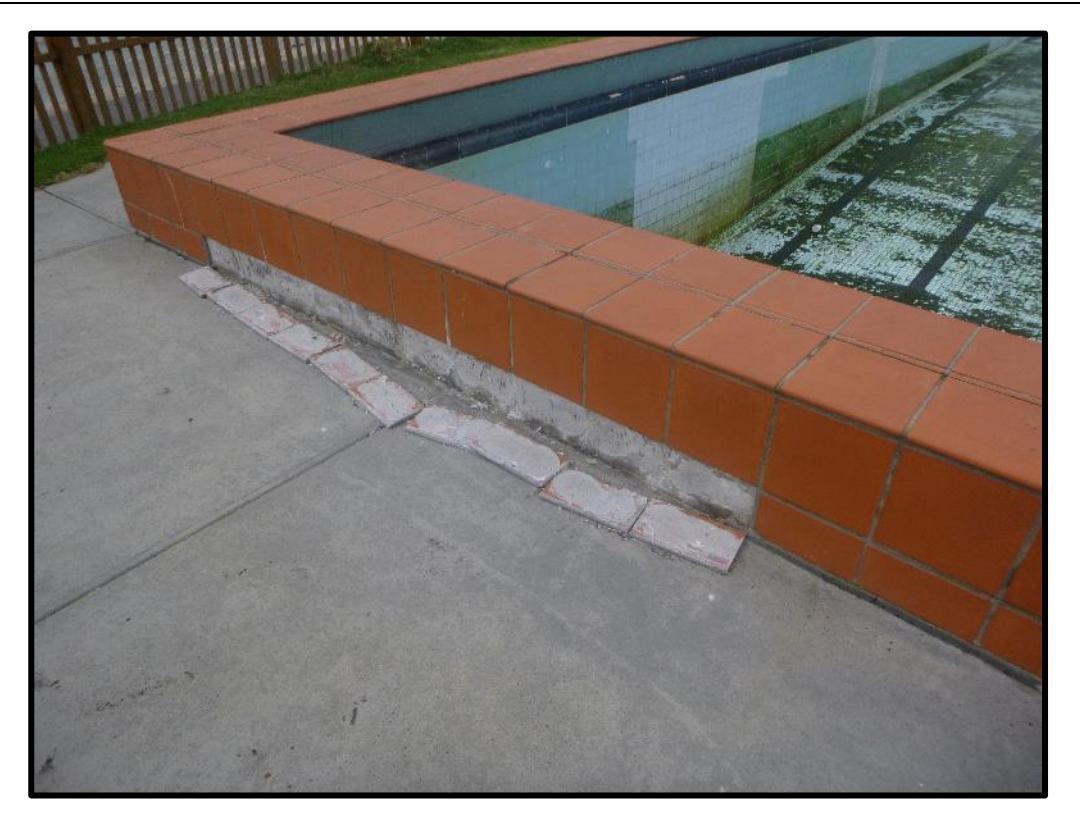
Photograph 11 - Tiles delaminated on northern end of coping beam

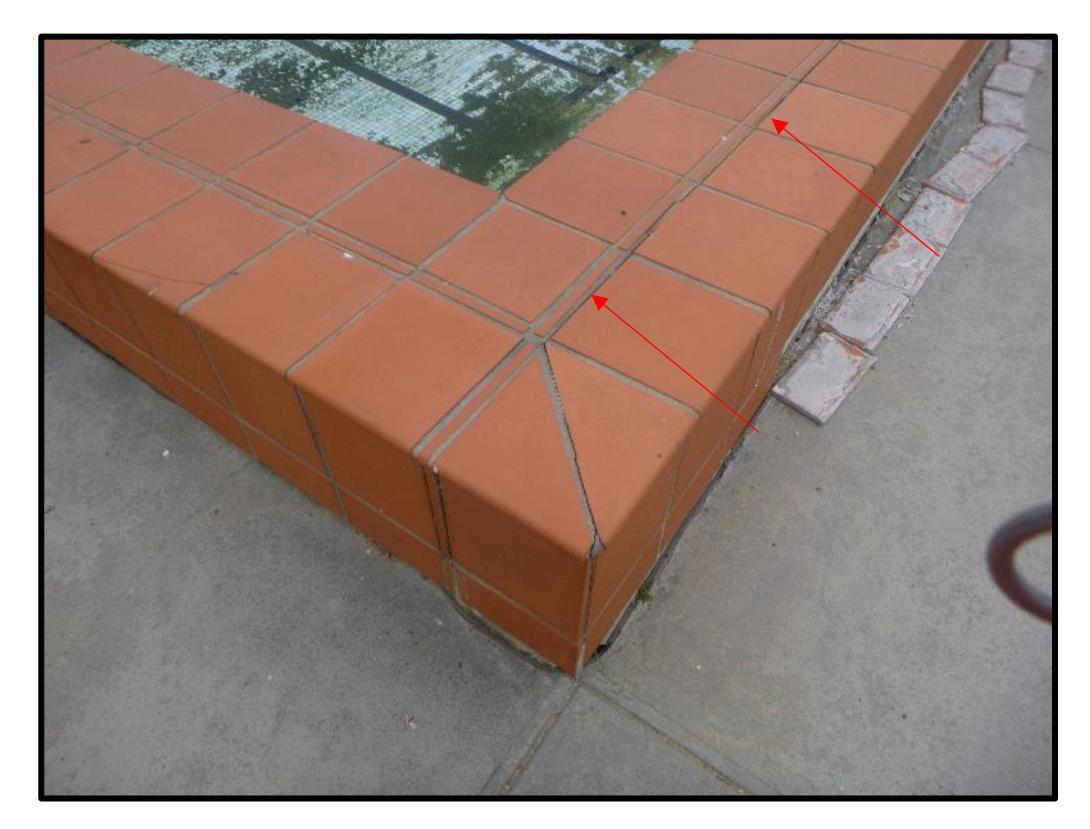
Photograph 12 – 'Acute' corner of the pool. Cracking along the centre of coping beam (northern end of pool).

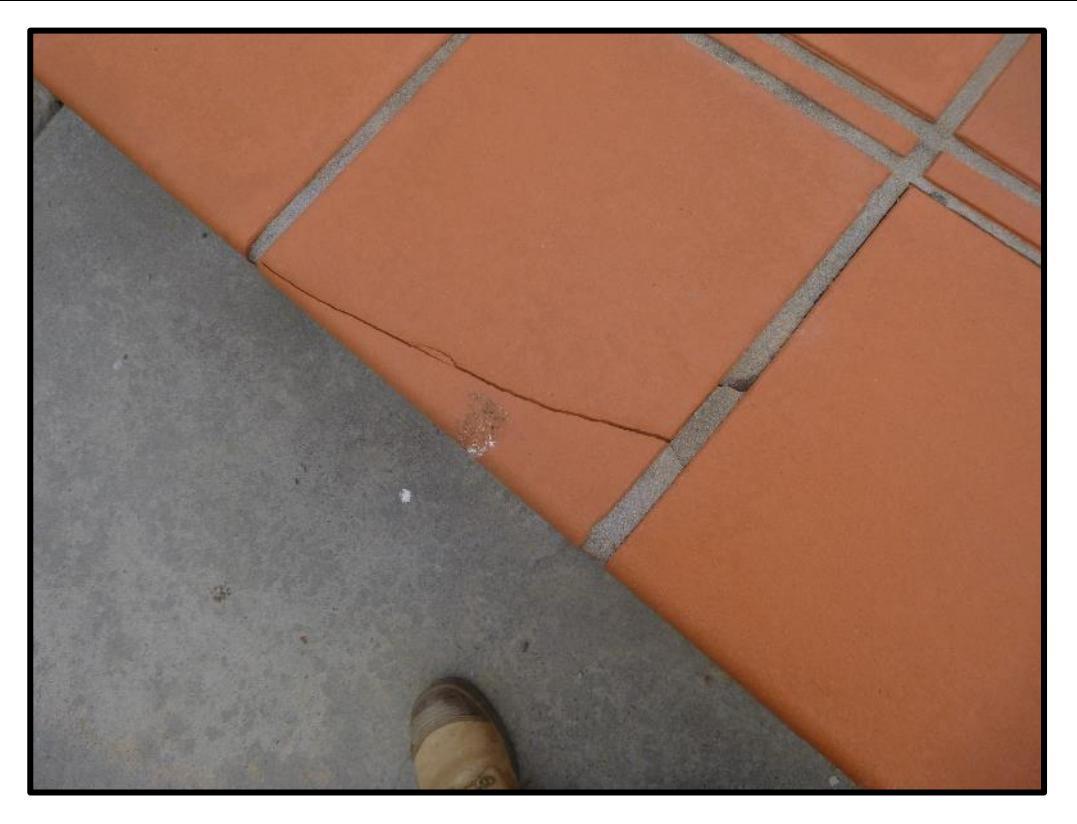
Photograph 13 - Cracked coping tile located near the north-east corner of the pool

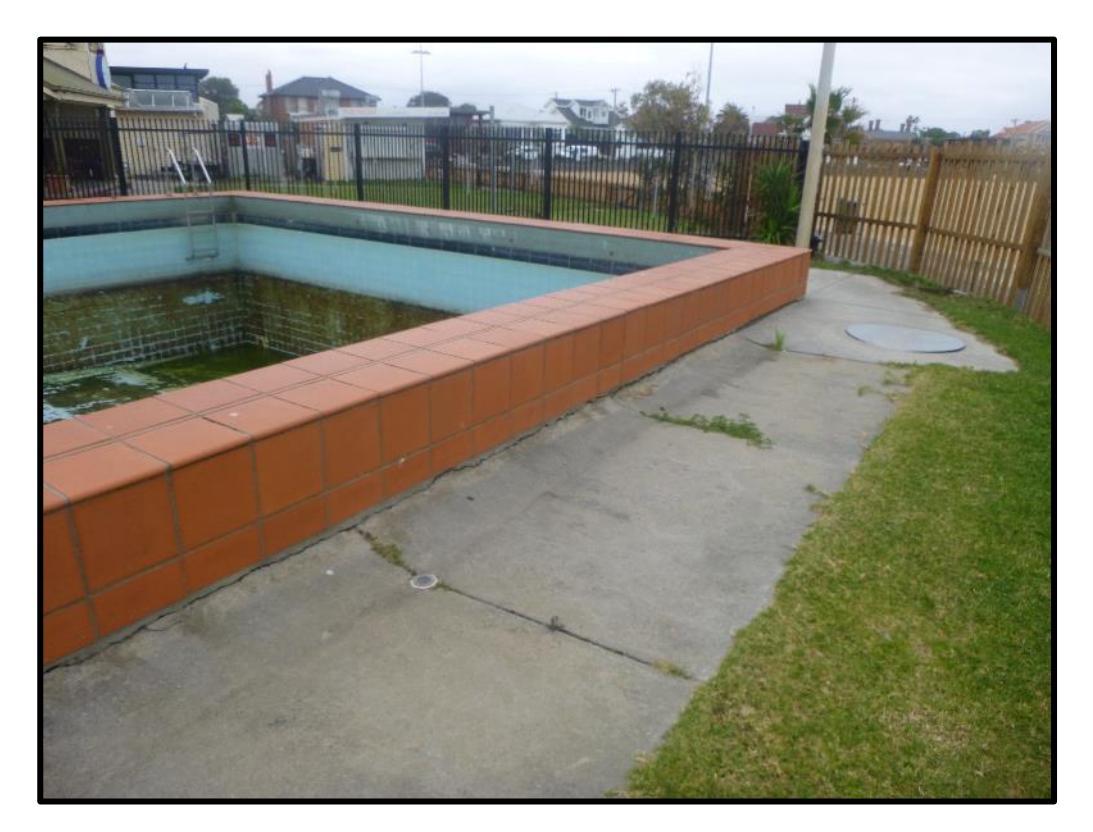
- Crack between the render/tiles and the concourse. North eastern side of the pool [14].
  - Mastic missing from northern construction joint, eastern end [15].

Photograph 14 – Crack between the render/tiles and the concourse. North eastern side of the pool

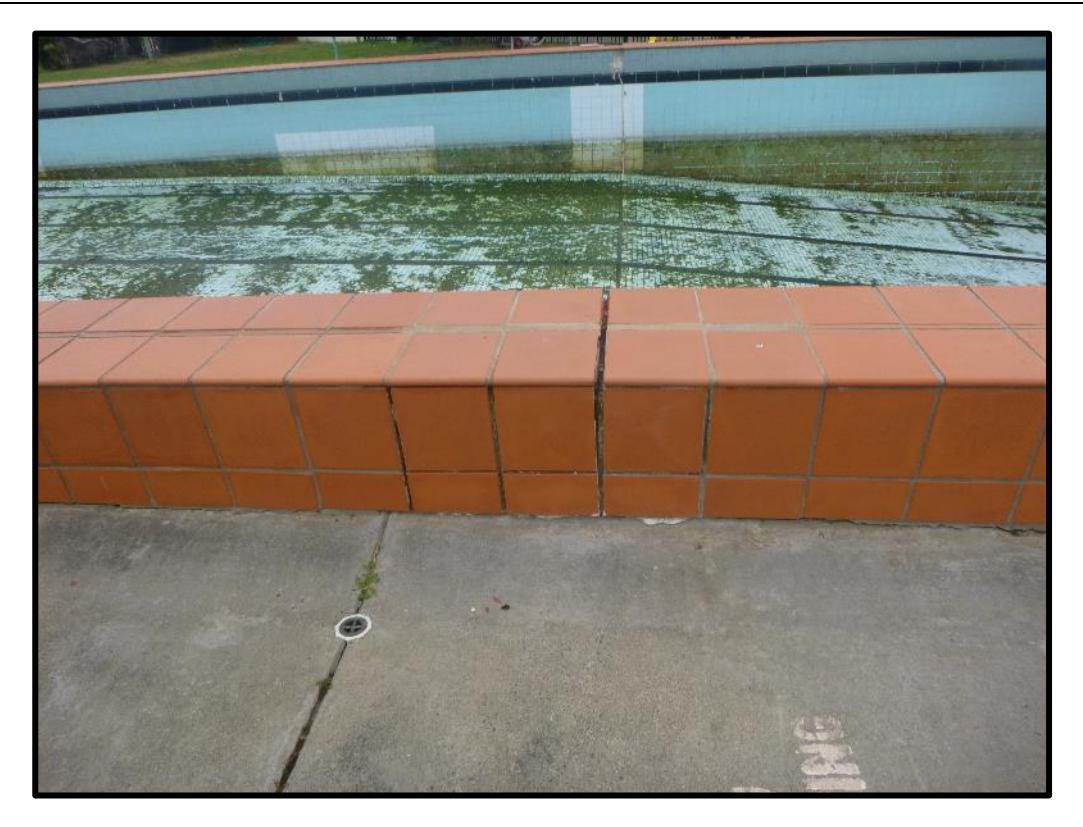
Photograph 15 – Mastic missing from northern construction joint, eastern end.

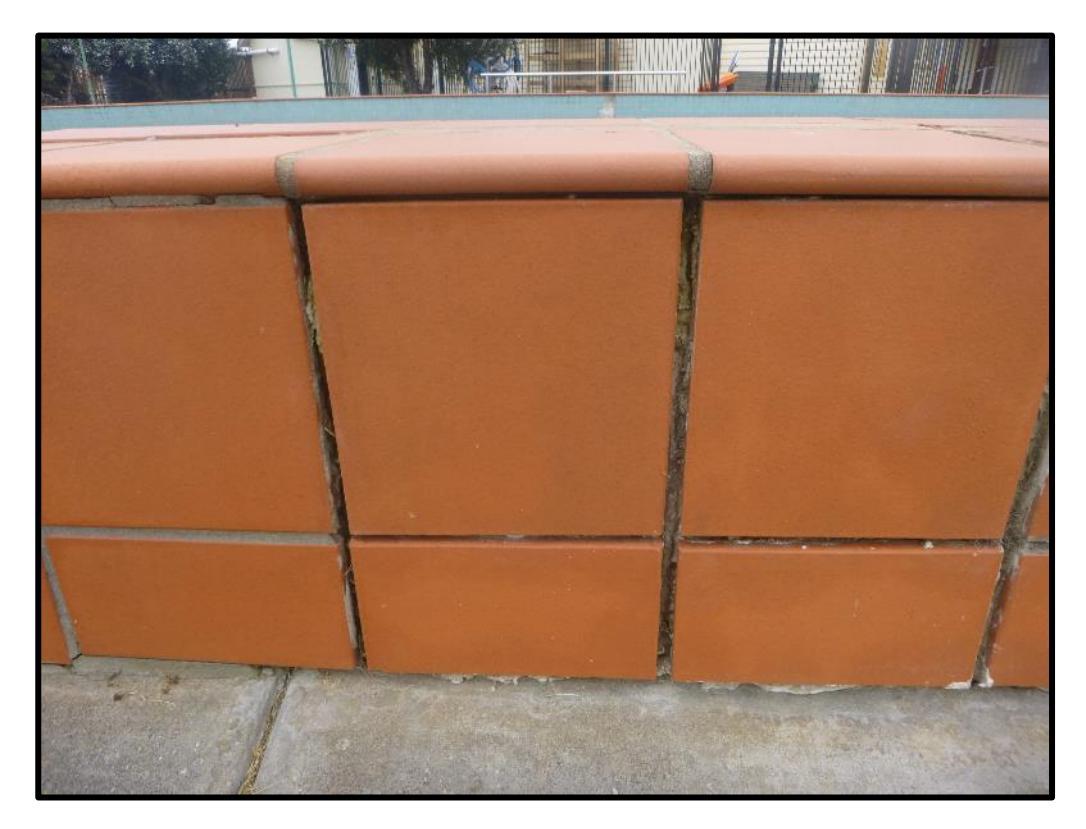
Photograph 16 – Grout missing from the between the coping beam tiles

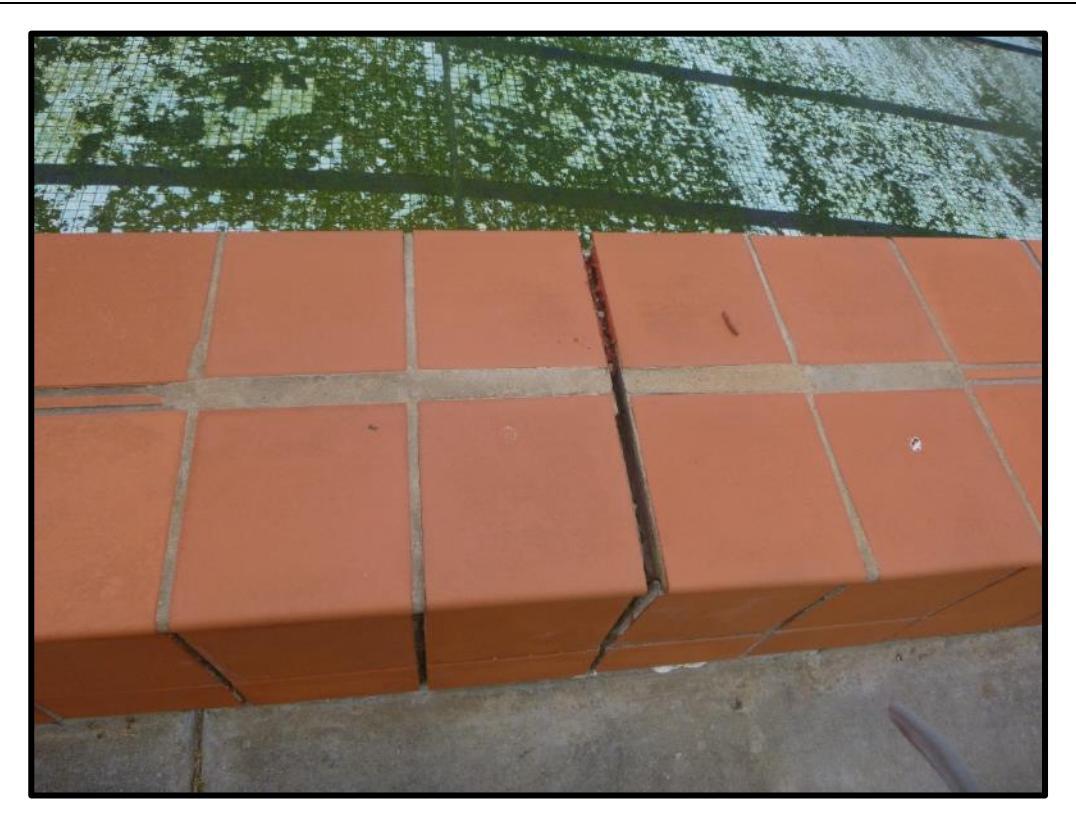
Photograph 17 – Mastic is missing from northern control joint, eastern end.

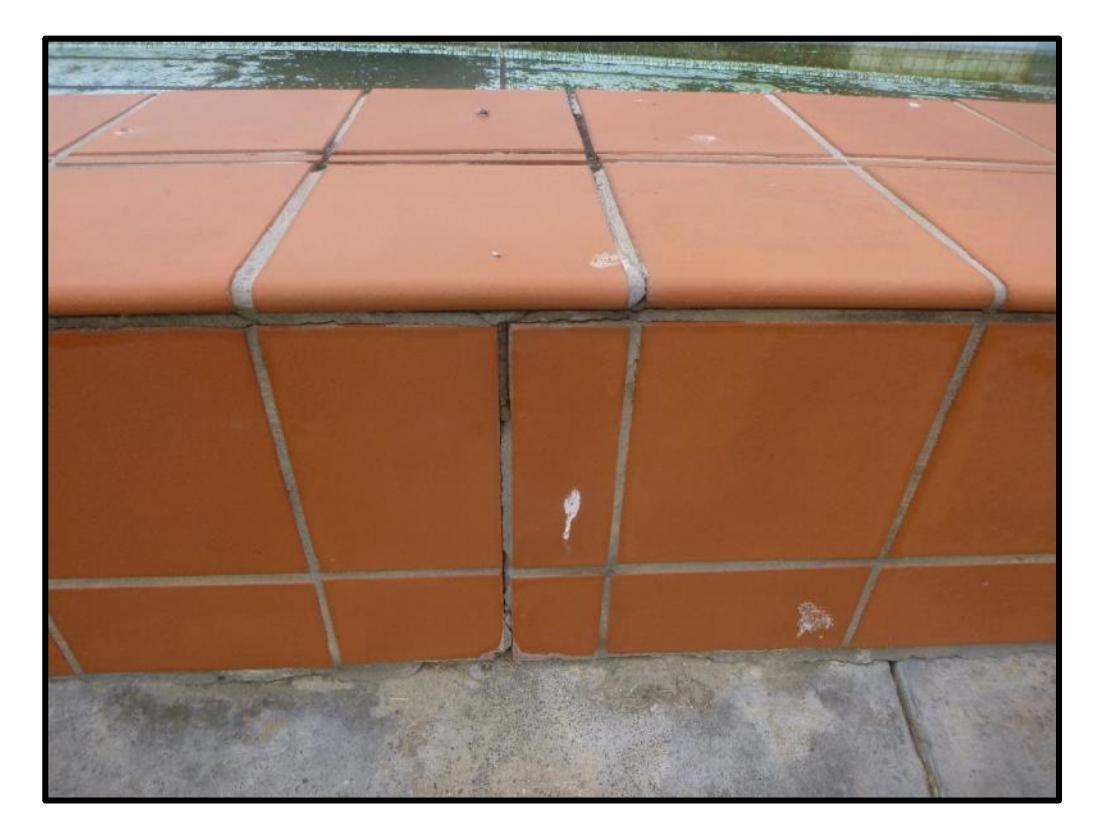
Photograph 18 – General cracking of the tiles around south-east control joint. The coping beam tiles are not discontinuous over the joint. No mastic has been used to allow movement to occur.

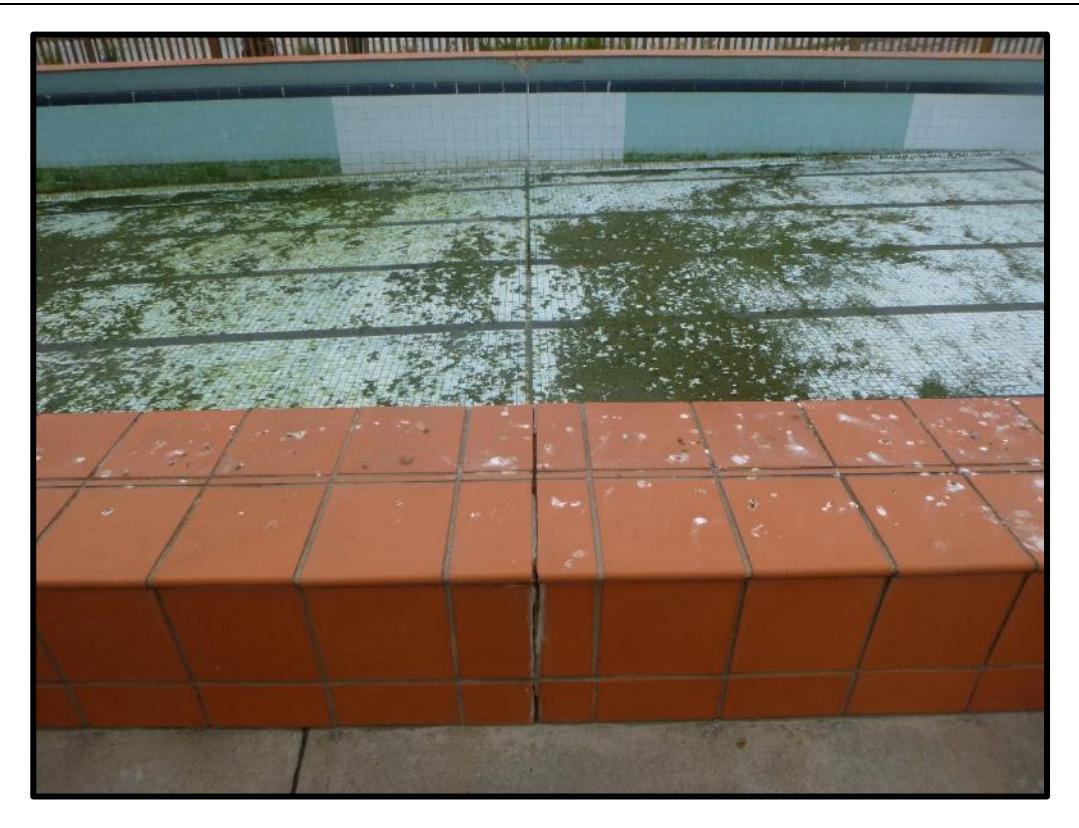
Photograph 19 – Mastic missing from southern control joint, eastern end

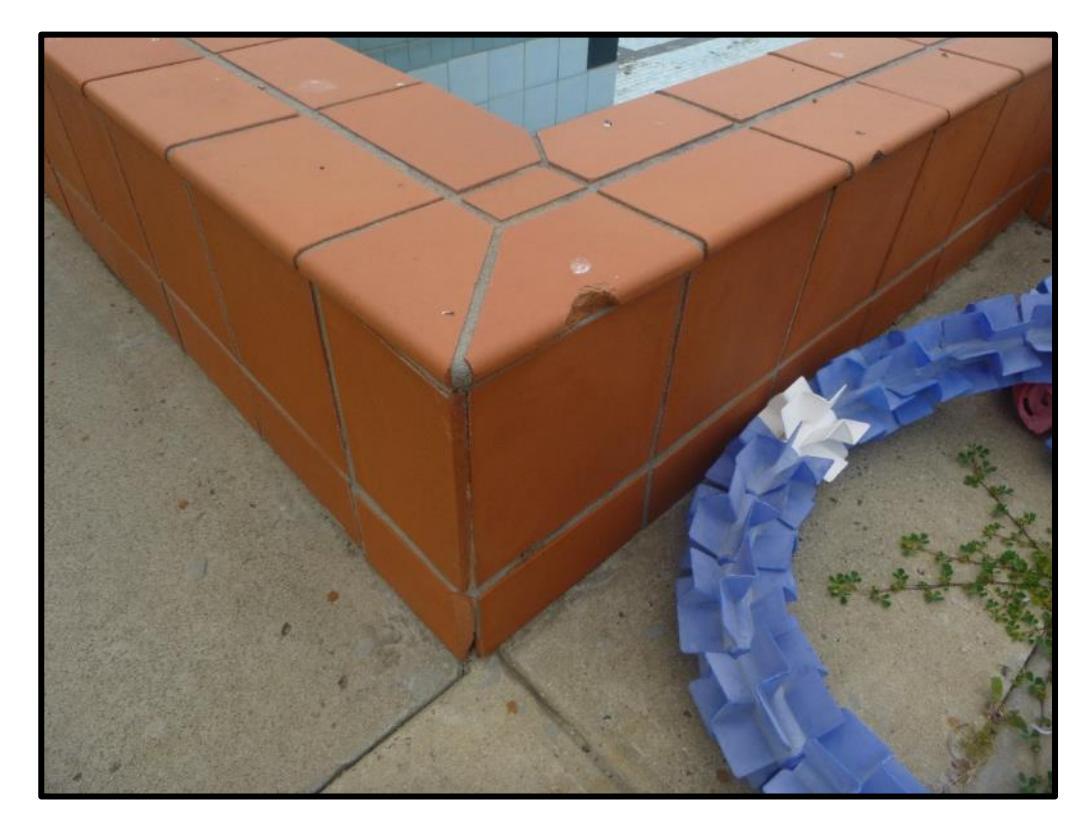
Photograph 20 – Chipped coping beam tile near southern stairs.

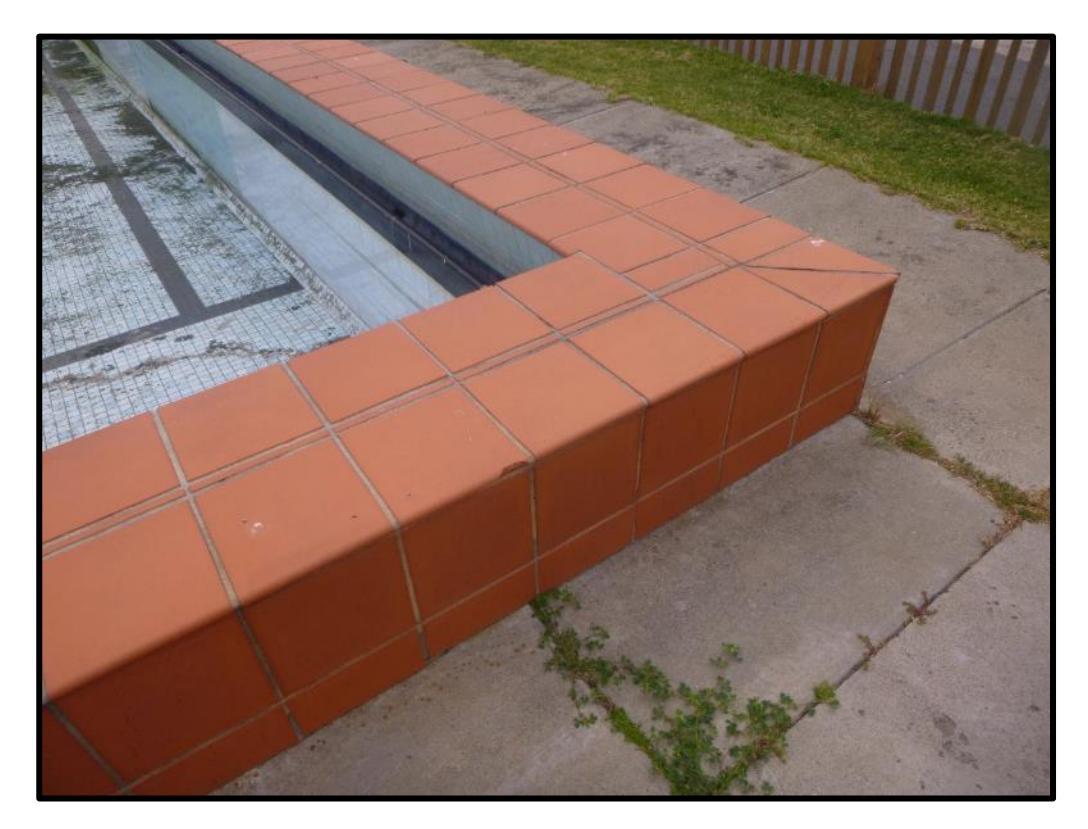
Photograph 22 - Chipped coping beam tiles located near the south-east corner

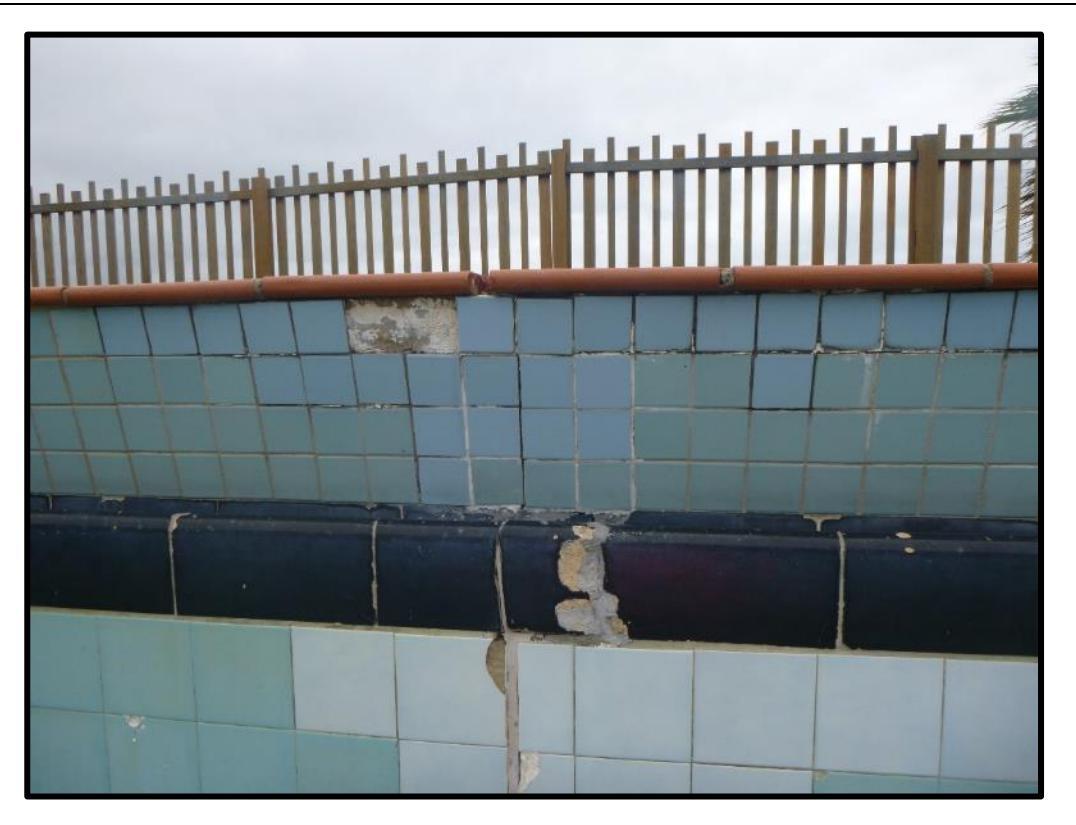
Photograph 23 – Damaged scum gutter tiles and wall tiles above the water line. Northern control joint, western end.

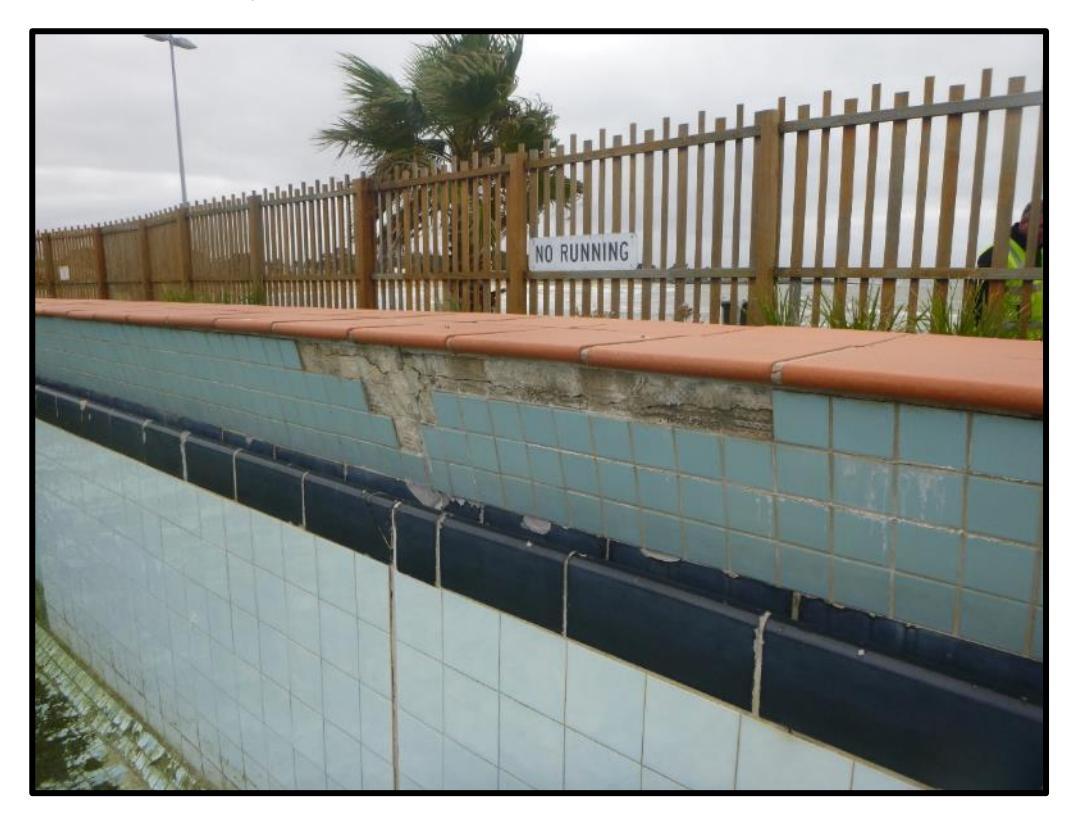
- Damaged scum gutter tiles [26] and wall tiles above the water line. Horizontal crack below the coping beam tiles (approximately 1.5mm wide [25]). Southern control joint, eastern end. [24]

- (2) Investigate two upper bulkhead locations for corrosion of reinforcement [24, 27]. The horizontal crack located near the construction joints in this location is a common occurrence when the reinforcement is corroding.

Photograph 24 – Damaged scum gutter tiles [26] and wall tiles above the water line. Horizontal crack below the coping beam tiles (approximately 1.5mm wide [25]). Southern control joint, eastern end.

- 4.9 If corrosion is found during any of the destructive testing then this will be repaired (within reason) during the destructive testing. FMG recommends that item (2) of the prescribed destructive investigation be undertaken this year prior to the opening the facility. FMG is of the opinion that items (1) and (3) can be undertaken next off season as they are not considered as critical by FMG.

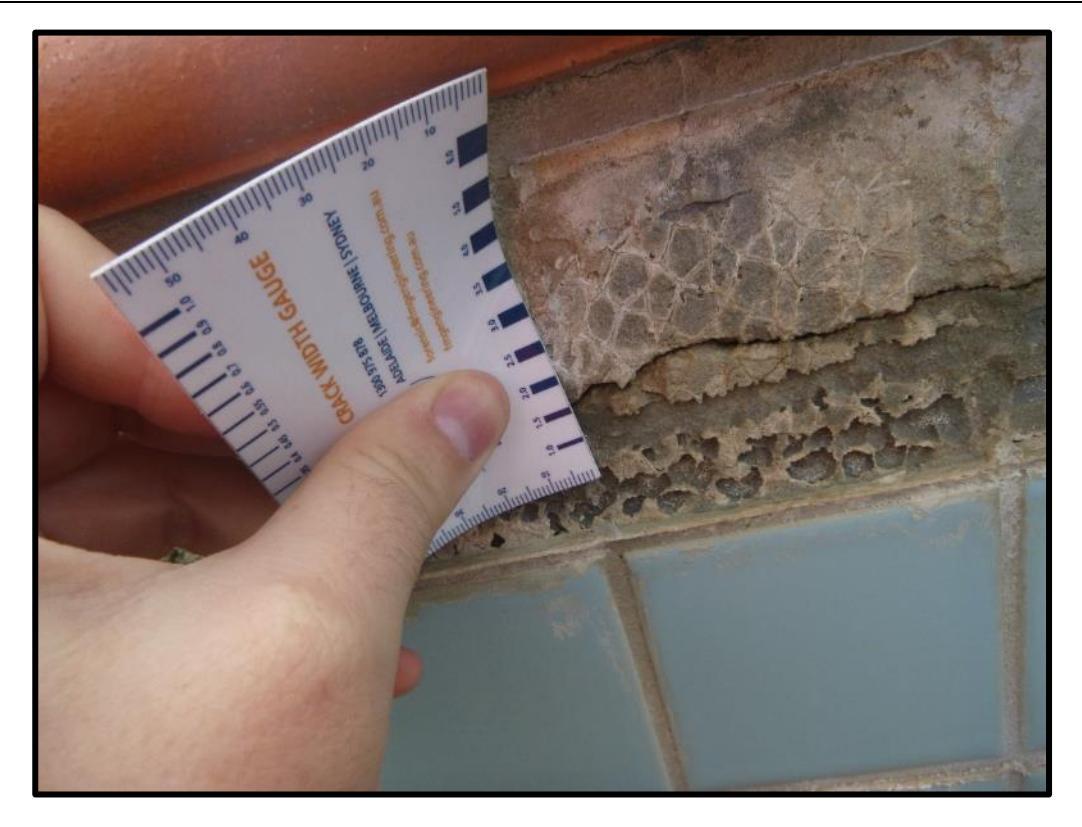
Photograph 25 – Horizontal crack below the coping beam tiles (approximately 1.5mm wide). Southern control joint, eastern end.

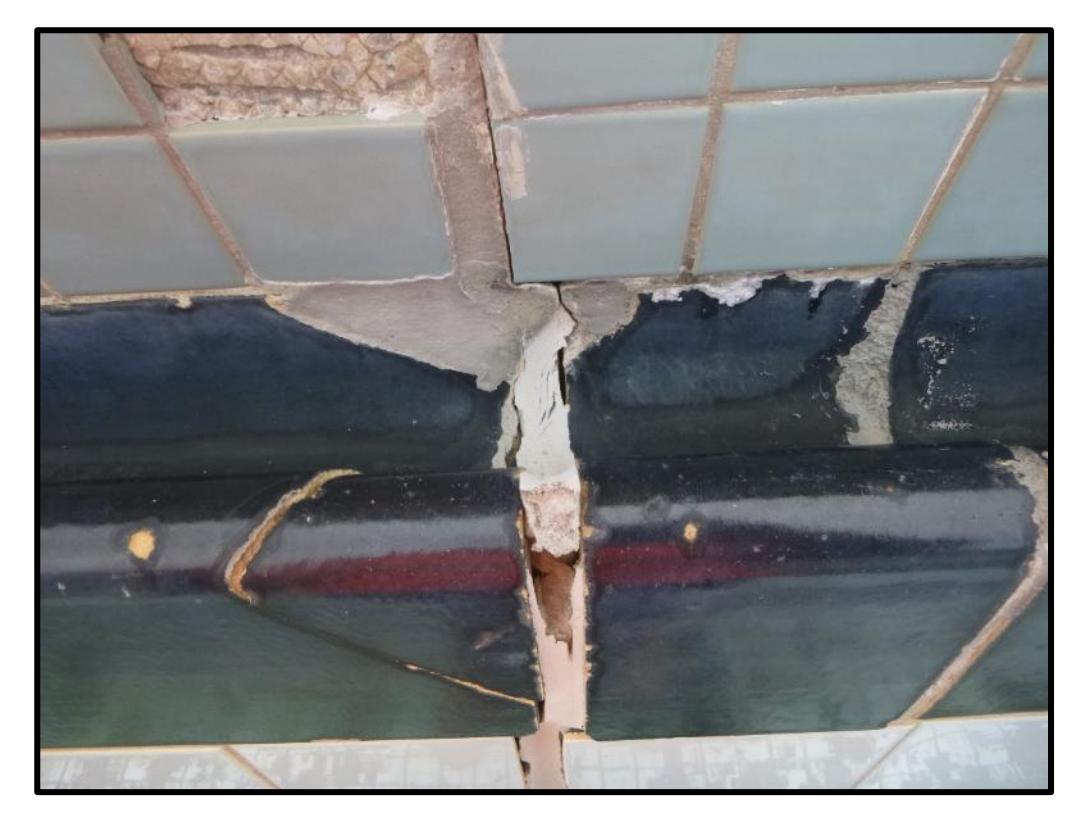
Photograph 26 – Damaged scum gutter tiles and missing mastic. Southern control joint, eastern end.
