# **Engineering Investigation Report**

| FMG REF: | S37718 - 258126 |
| SITE ADDRESS: | 100 Esplanade, WILLIAMSTOWN, VIC 3016 |
| CLIENT: | Hobsons Bay City Council |

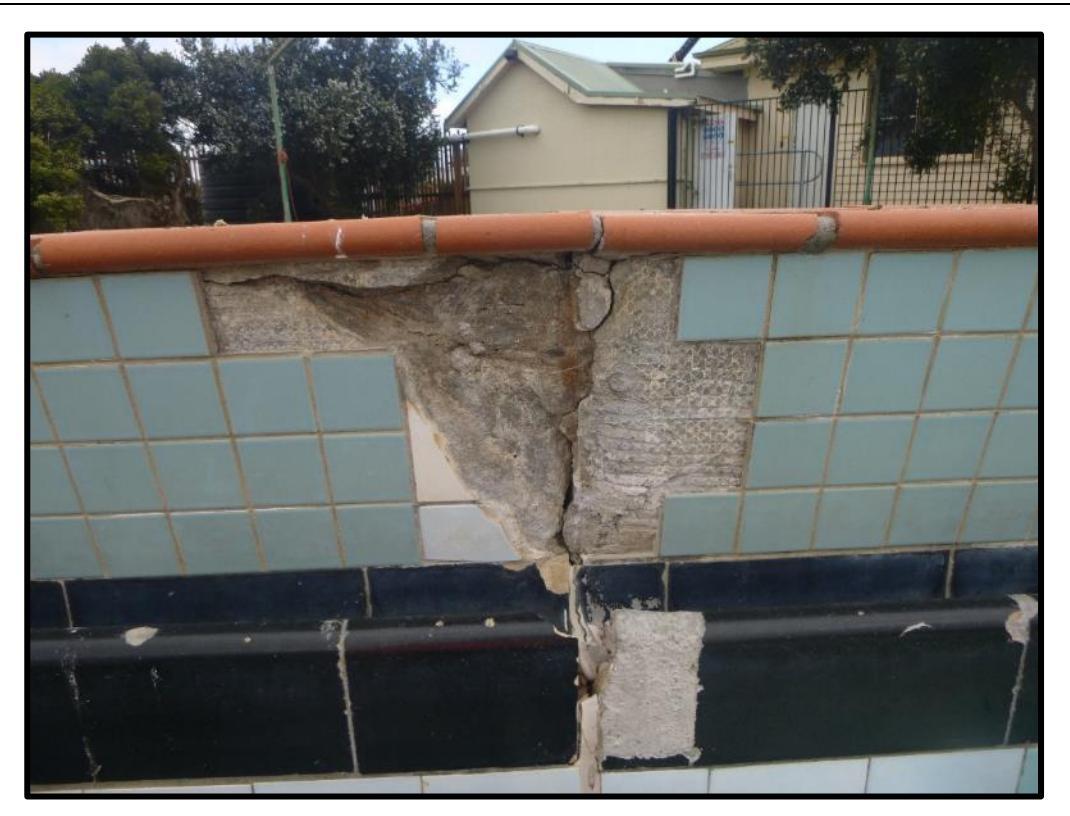
- Damaged scum gutter tiles [28] and wall tiles above the water line. Horizontal crack below the coping beam tiles. Southern control joint, western end. [27]

- (2) Investigate two upper bulkhead locations for corrosion of reinforcement [24, 27]. The horizontal crack located near the construction joints in this location is a common occurrence when the reinforcement is corroding.

Photograph 27 – Damaged scum gutter tiles [28] and wall tiles above the water line. Horizontal crack below the coping beam tiles. Southern control joint, western end.

- 4.9 If corrosion is found during any of the destructive testing then this will be repaired (within reason) during the destructive testing. FMG recommends that item (2) of the prescribed destructive investigation be undertaken this year prior to the opening the facility. FMG is of the opinion that items (1) and (3) can be undertaken next off season as they are not considered as critical by FMG.

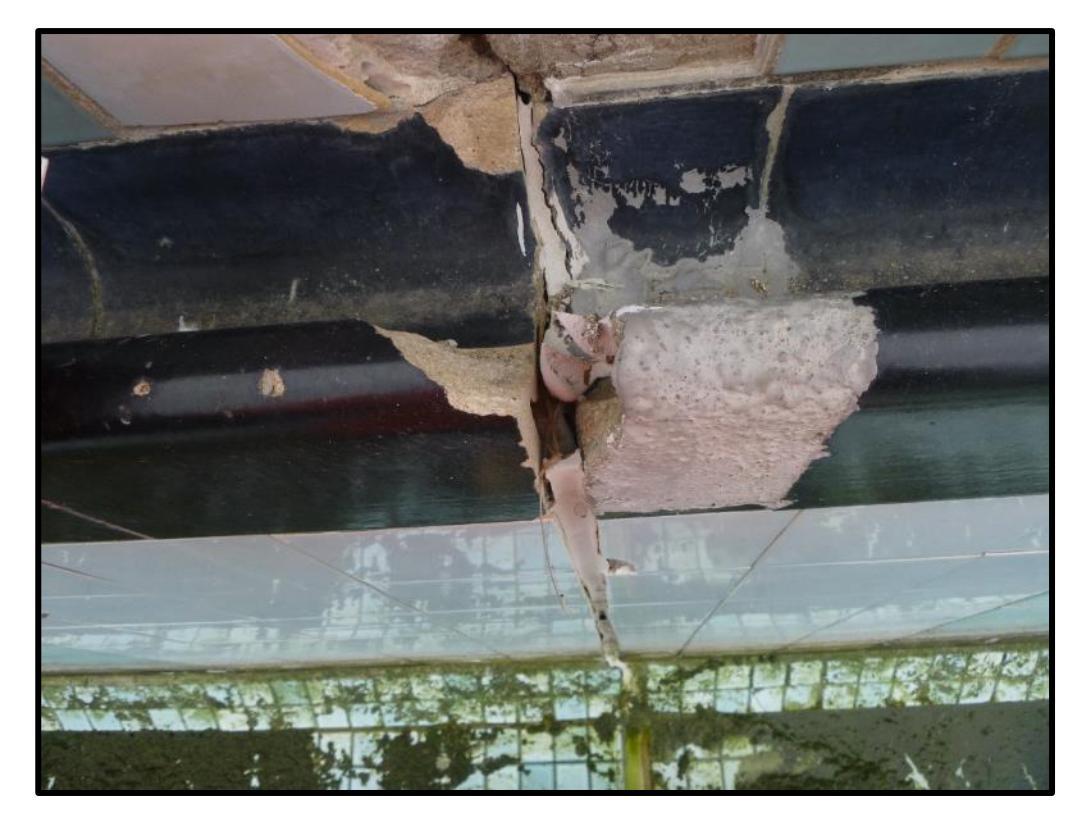
Photograph 28 – Significant damage to the south-east control joint scum gutter tile. Southern control joint, western end.

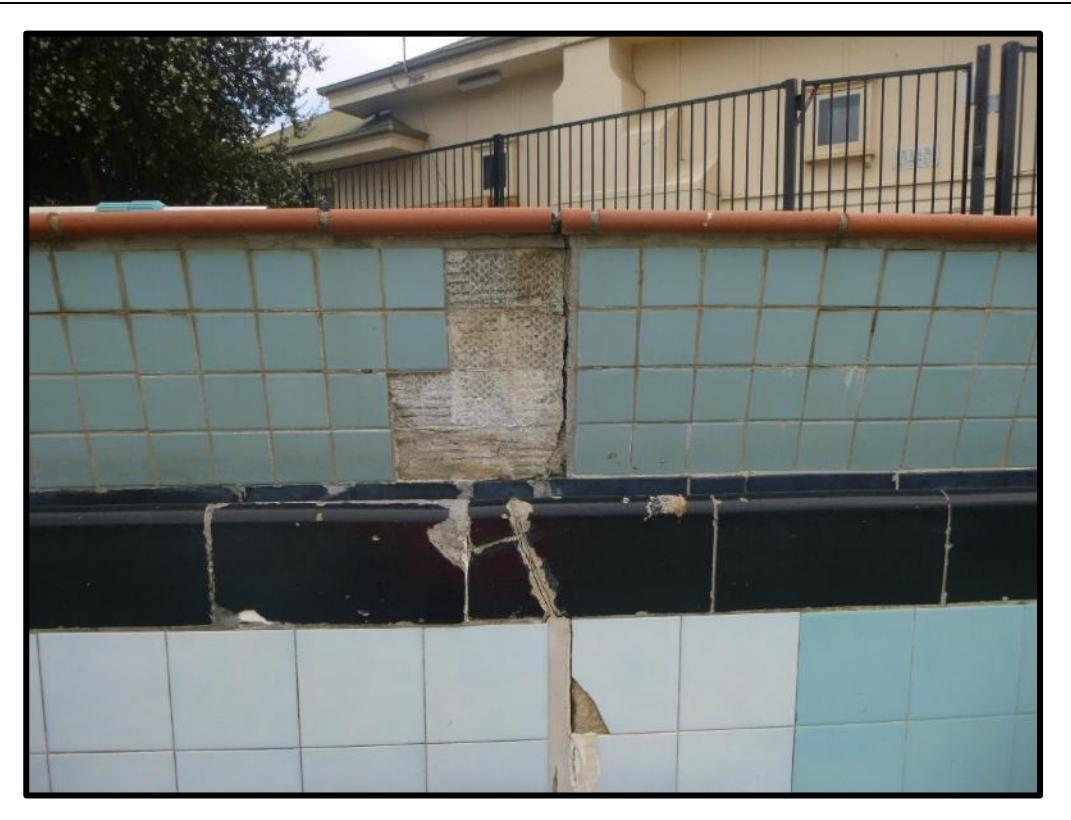
Photograph 29 – Damage to the wall tiles above and below the water line. Scum gutter tiles are also damaged. Northern control joint, western end

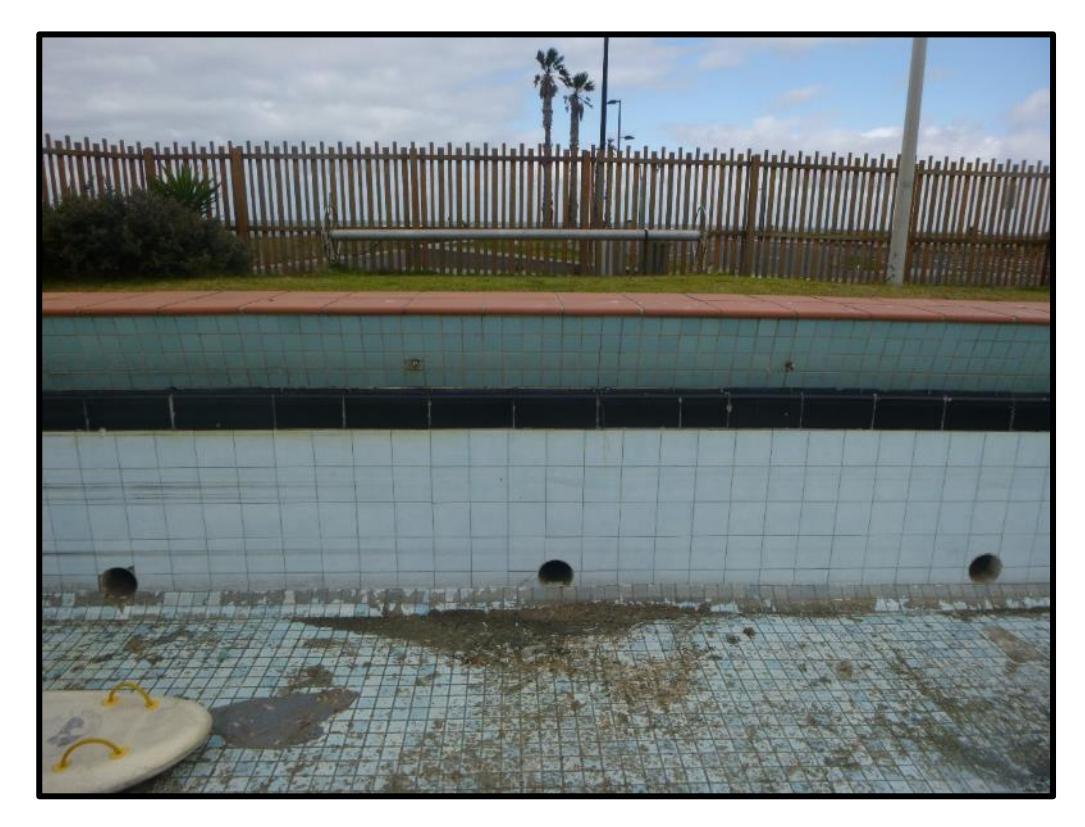
Photograph 30 – Minor damage to tiles around pipe returns.

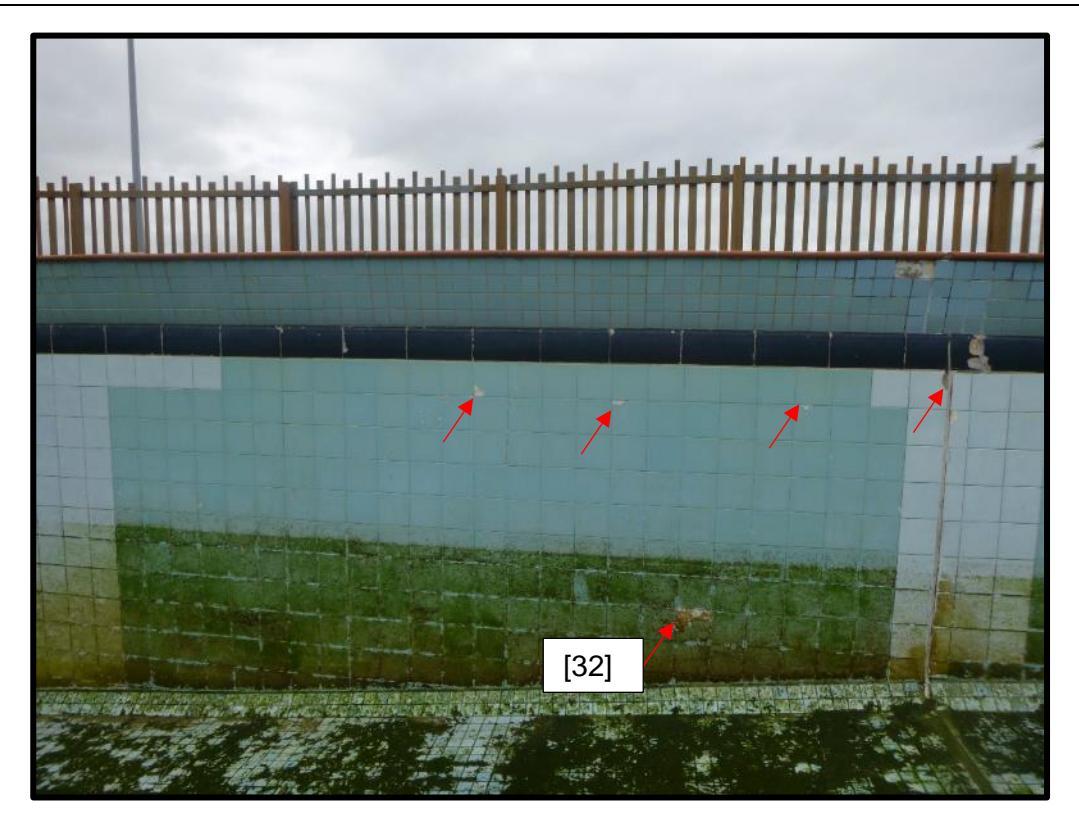
Photograph 31 – General damage to wall tiles throughout. This photograph is of the eastern wall located towards the north

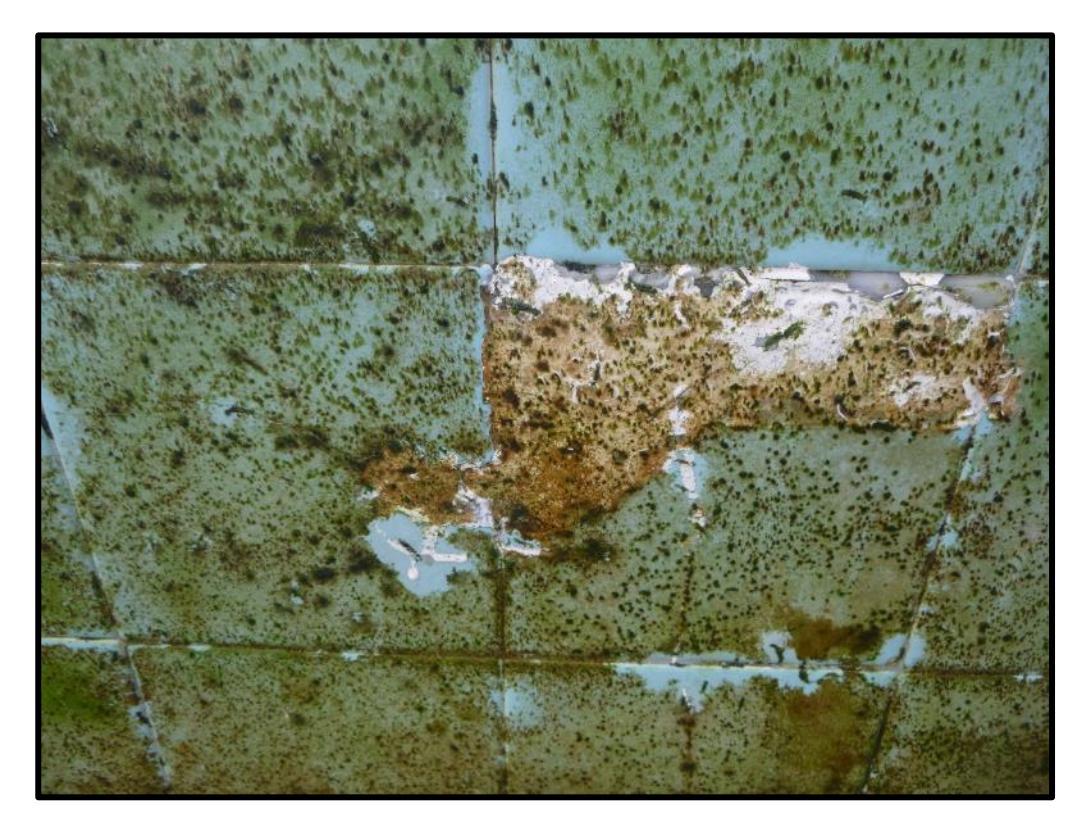
Photograph 32 – damaged tile to be investigated

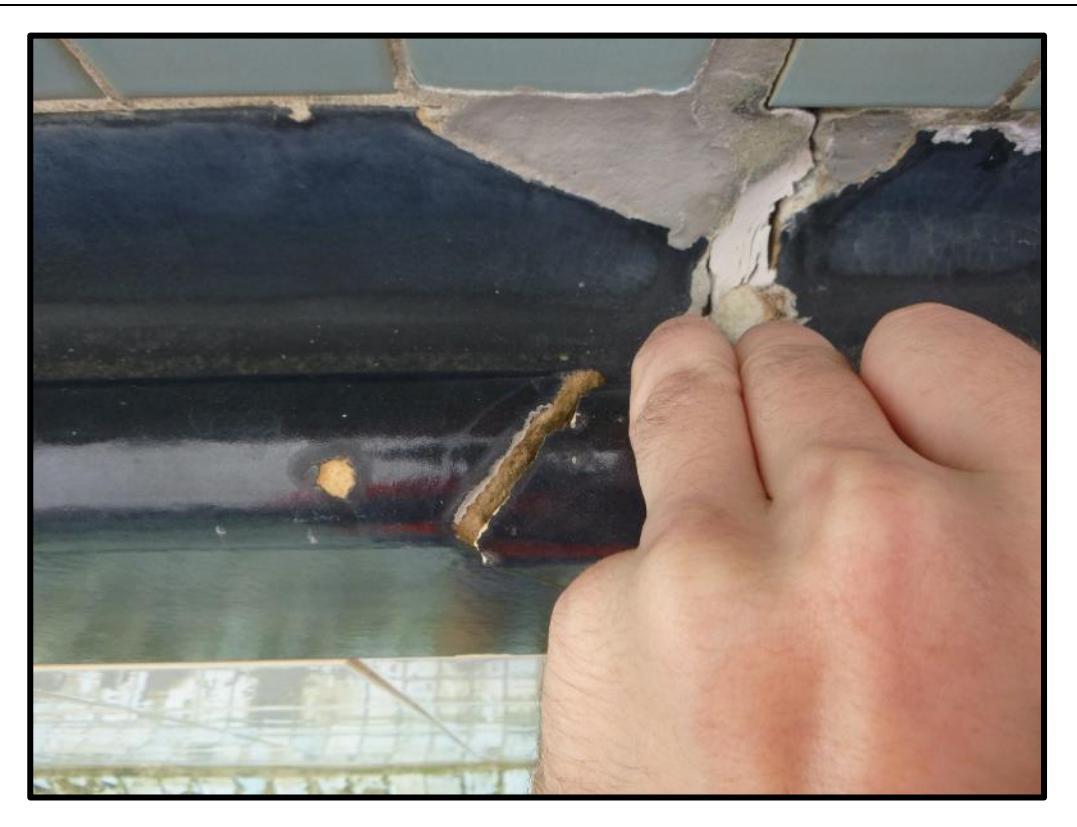
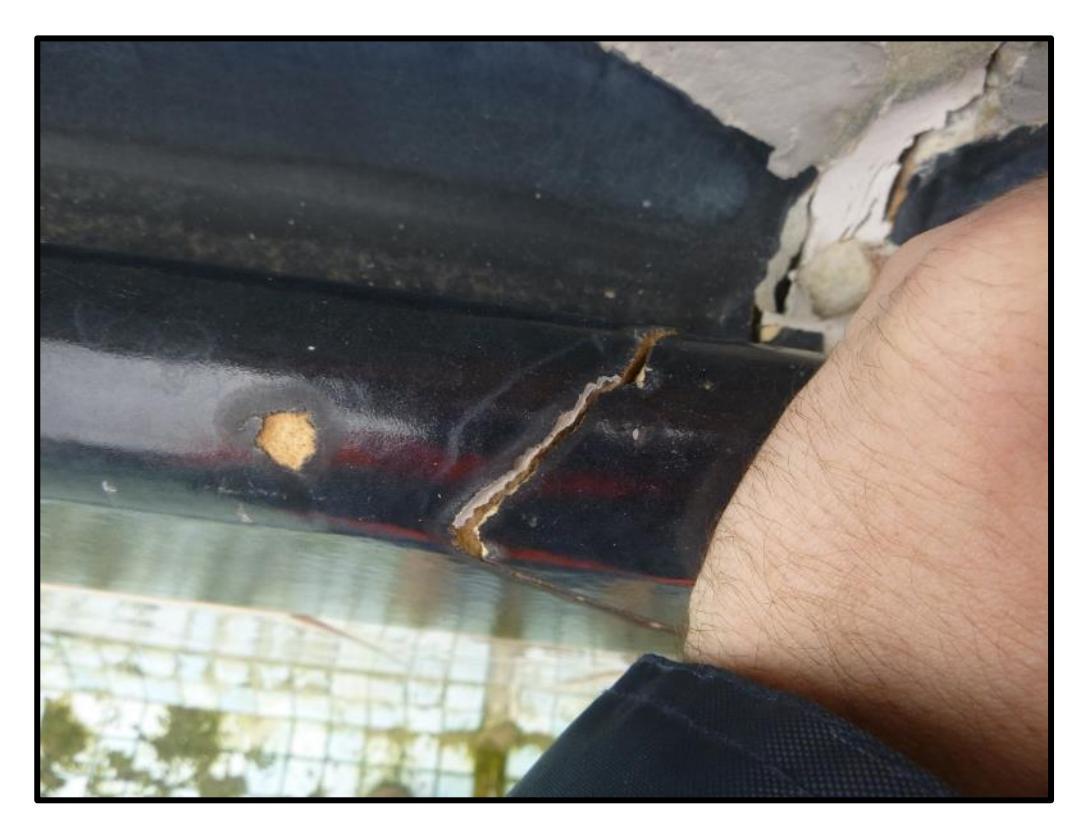
Photograph 33 – Damaged scum gutter tile piece being held in place by mastic allowing movement of the damaged tile. Southern control joint, eastern end.

Photograph 34 – Damaged scum gutter tile piece being held in place by mastic allowing movement of the damaged tile. Southern control joint, eastern end.

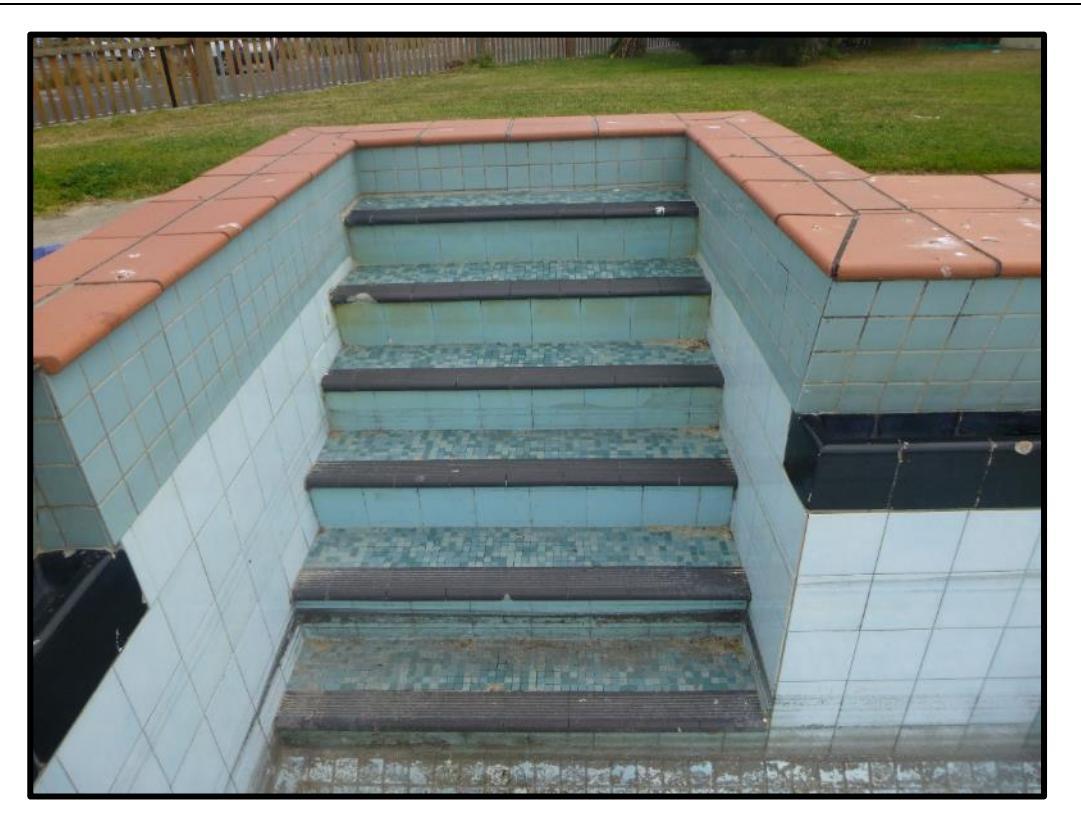
Photograph 35 – No grout remains between mosaics at the steps

- (2) Prior to retiling the pool, it is FMG's recommendation that a plan is put in place to grind/sand any sharp tiles within the pool and the coping beam each year. If the pool is not to be re-tiled within a short period of time (next two years) FMG recommend that new epoxy grout is installed between the small mosaic tiles located on the steps. This is to prevent minor cuts and abrasions on the patrons' feet.

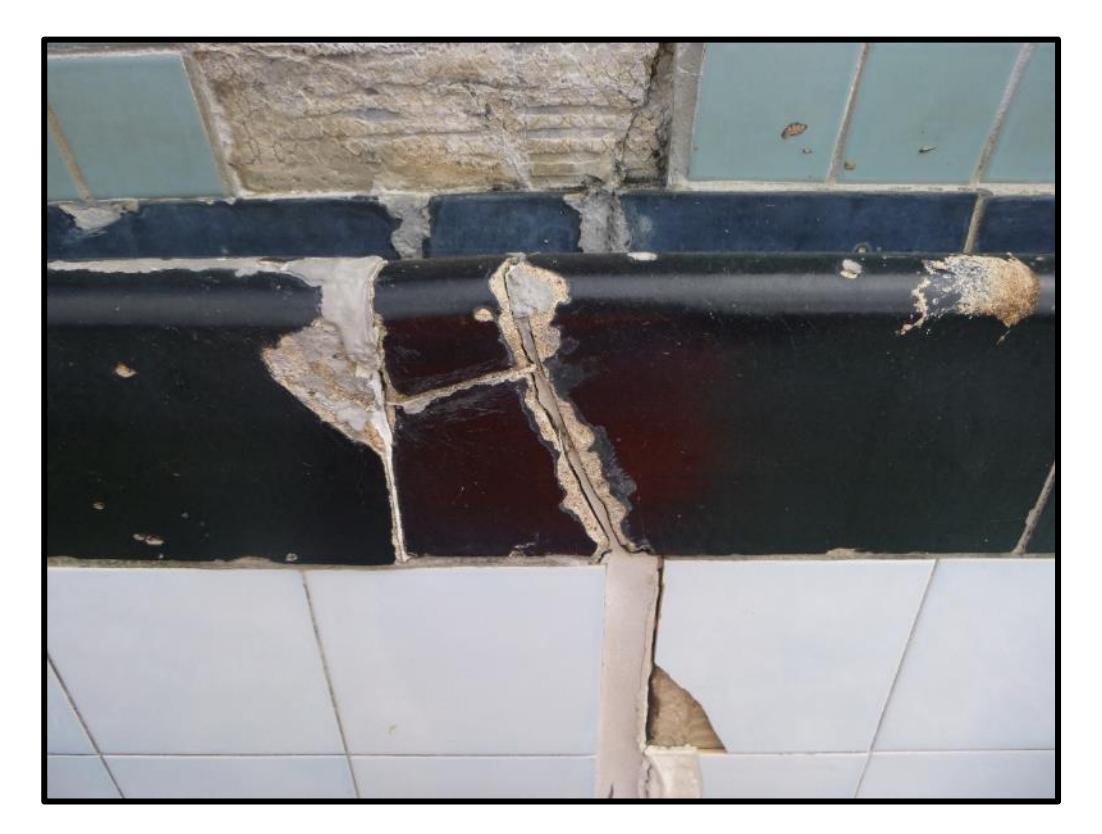
Photograph 36 – Scum gutter tile is continuous over the construction joint (Northern control joint, western end) and has cracked as a result.

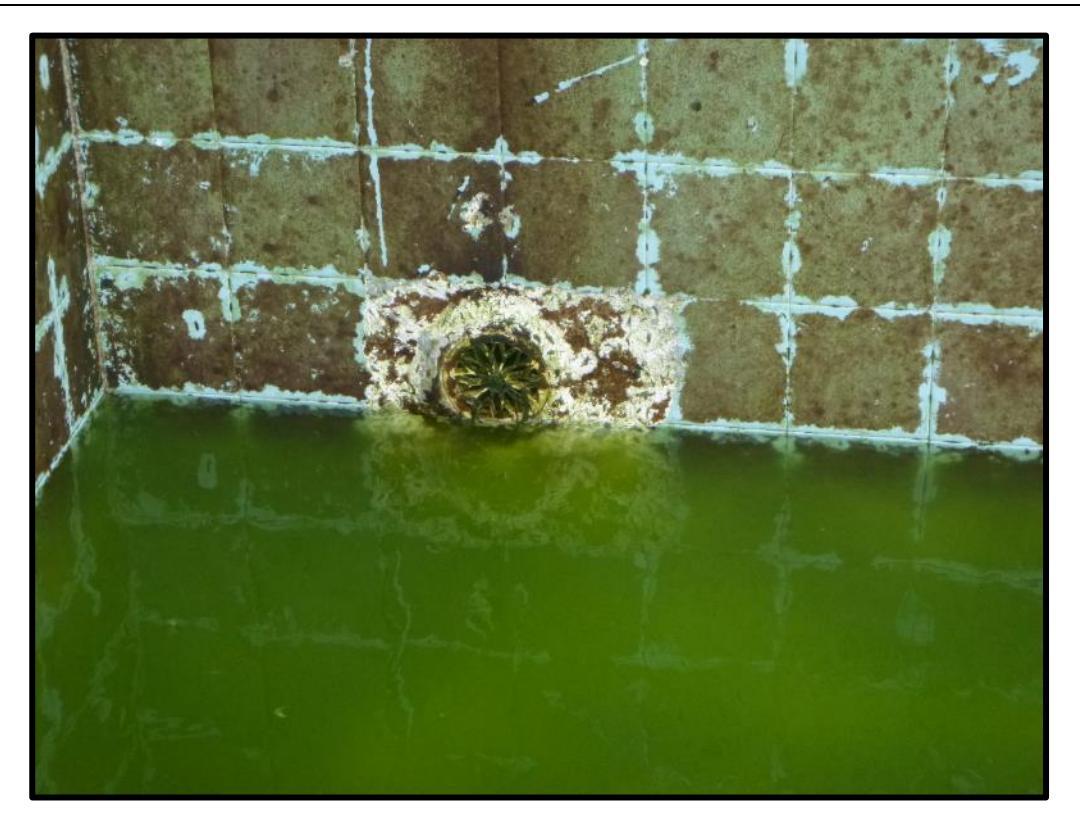
Photograph 37 – Evidence of previous repairs around gravity suction

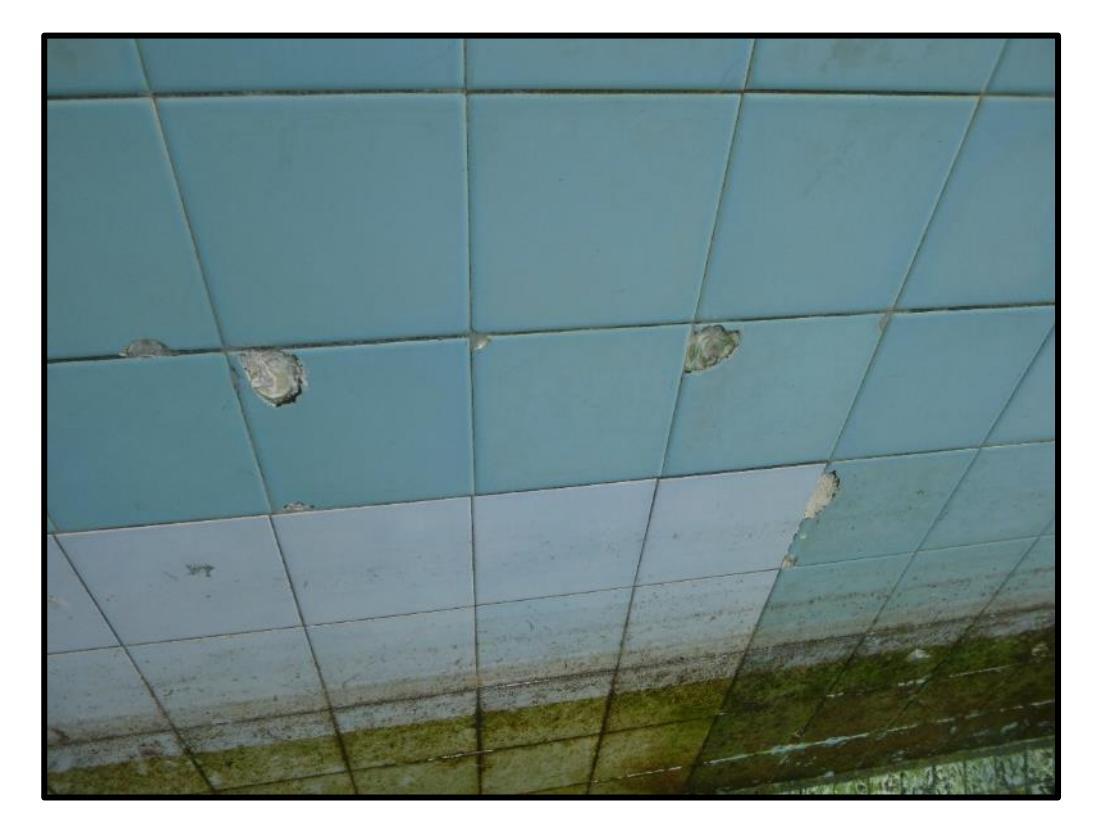
Photograph 38 – General damage to wall tiles

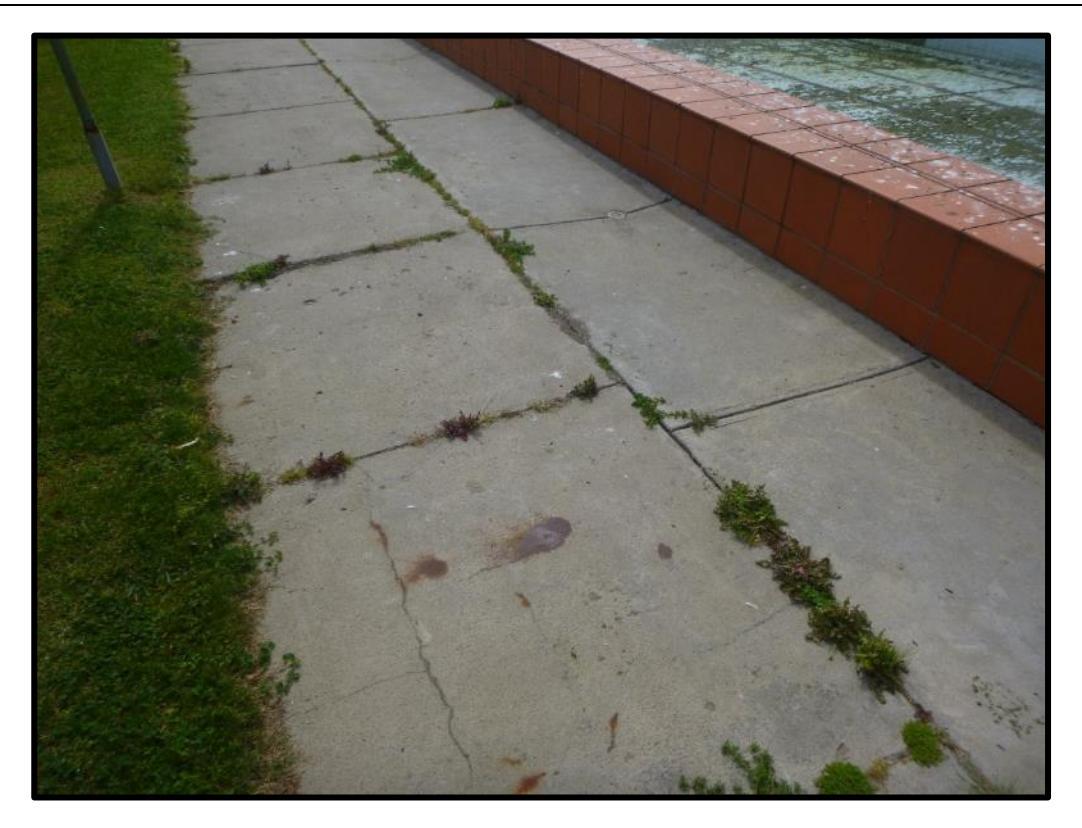
Photograph 39 – Typical photograph of concourse. Possible corrosion of concourse reinforcement.

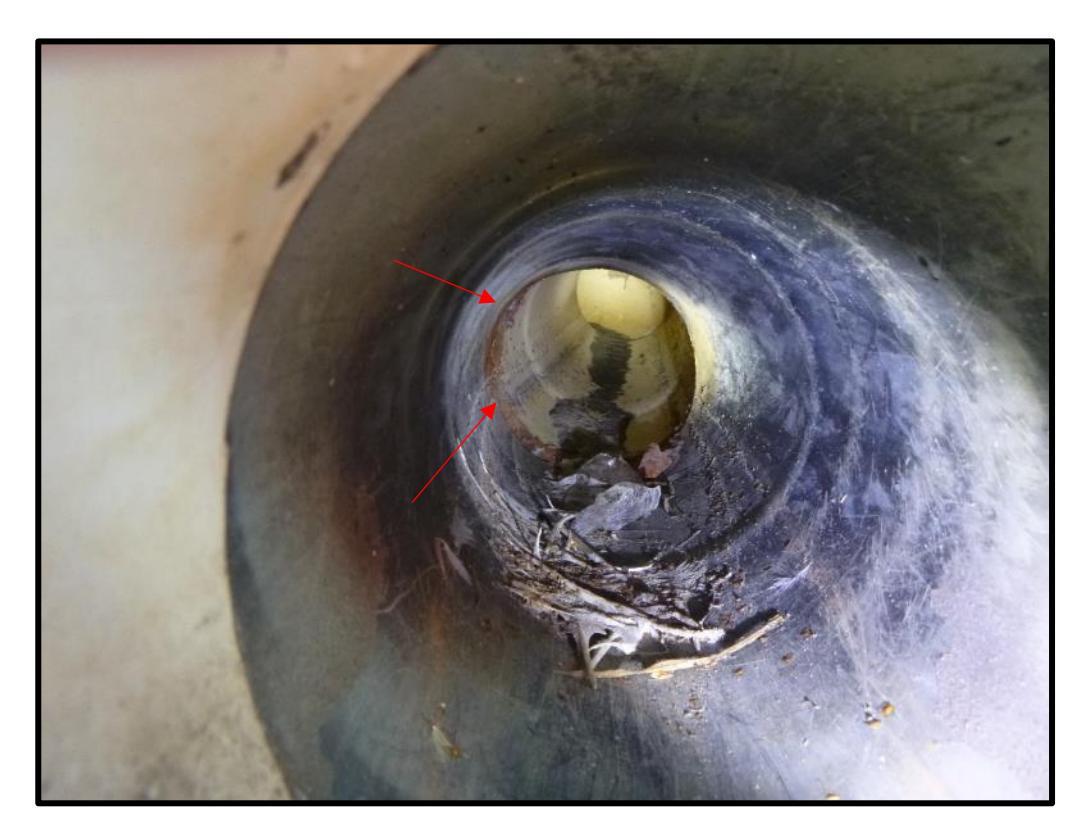
Photograph 40 – Joint between original and new PVC filtered water return pipes is a possible source of water loss.

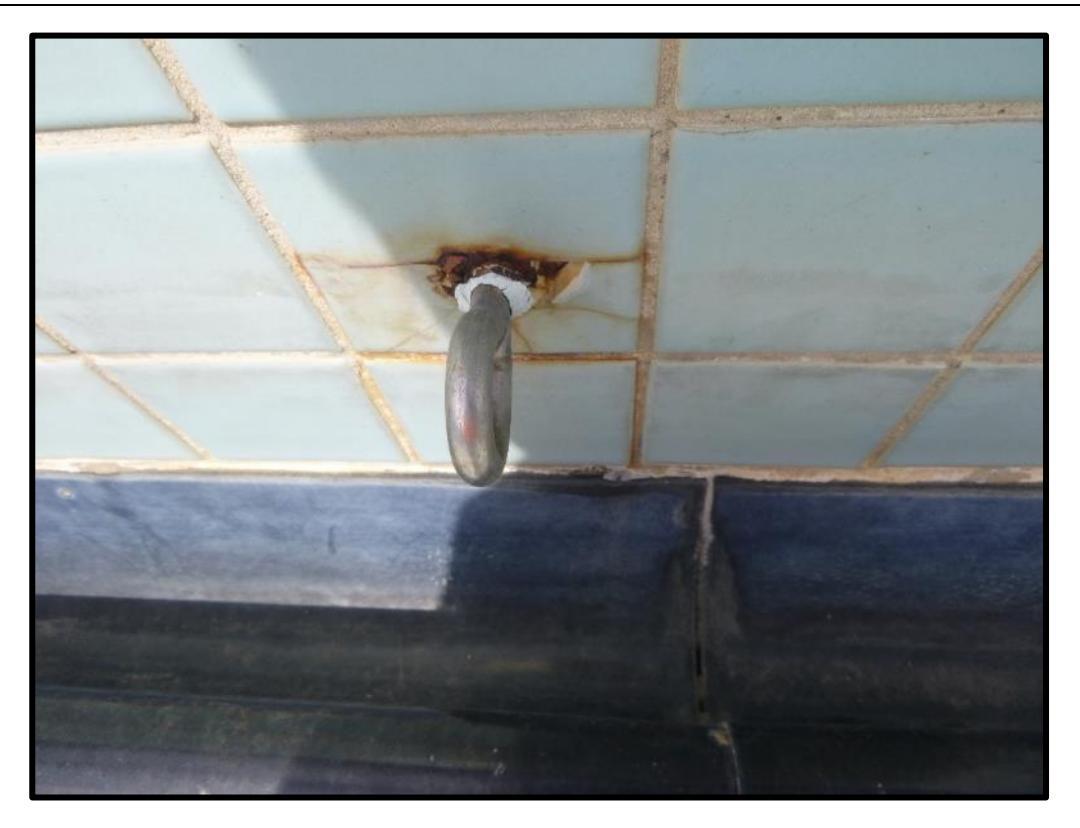
Photograph 41 – Corrosion of lane rope anchors

- (6) The stainless-steel items should be maintained using appropriate products. The lane rope anchors and ladder fixings will likely require replacement in the next three years.
- 4.16 Improvements to the pool could also be undertaken such as modifying the pool to include a wet-deck instead of a scum gutter or even simply a shorter hob. This will improve visibility of the pool for life guards or parents supervising children. A renovation system such as the 'Myrtha RenovAction' may also be suitable for this pool.

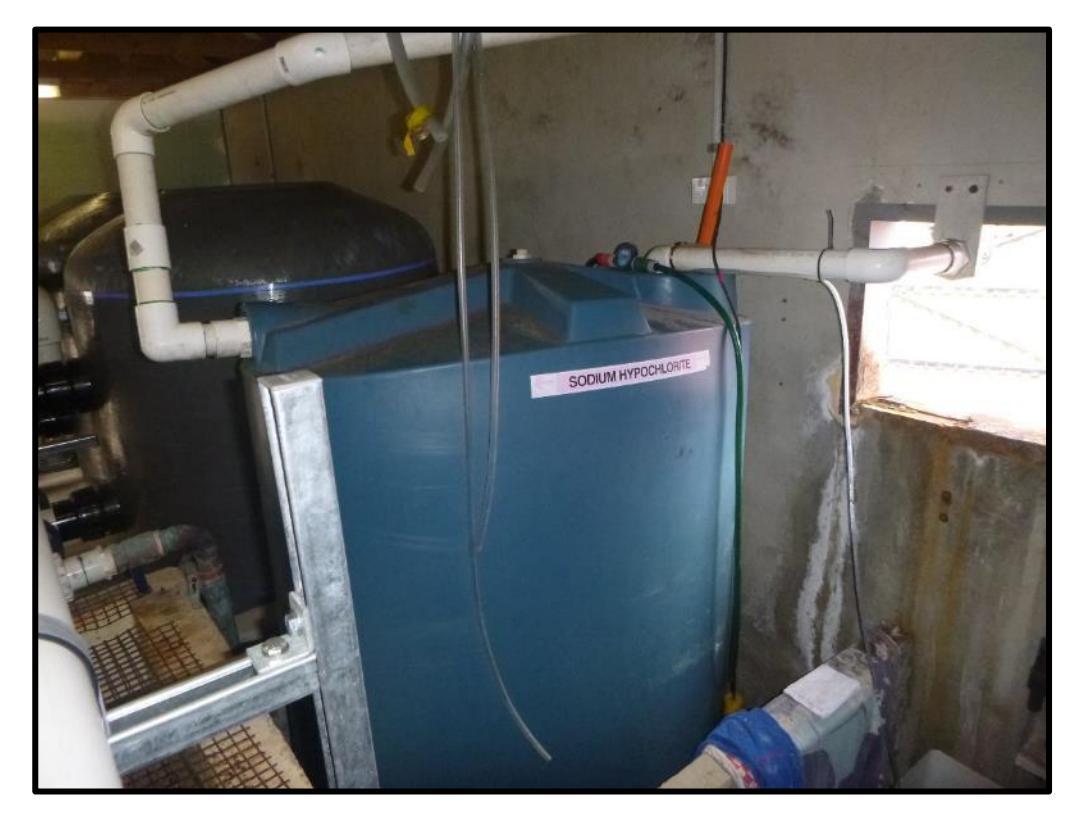
Photograph 42 – Sodium hypochlorite storage located directly against hydrochloric acid [43].

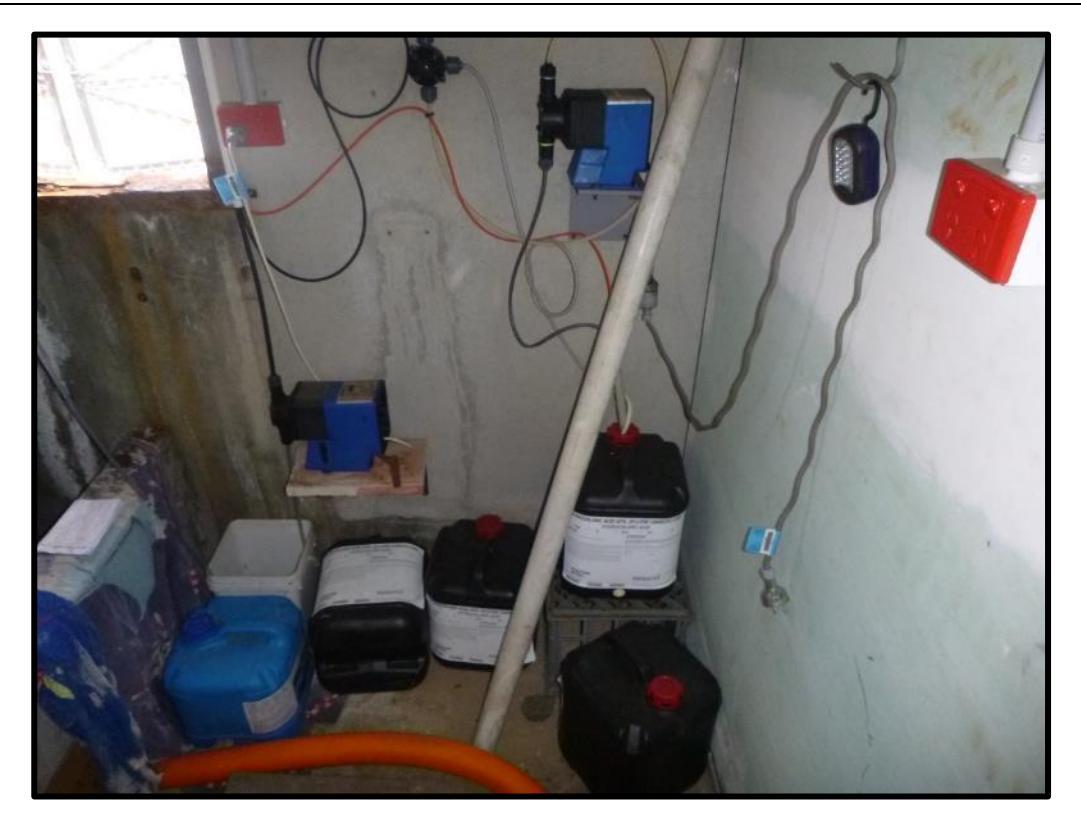
Photograph 43 – Hydrochloric acid is not stored within a bund. Acid is stored directly next to sodium hypochlorite.

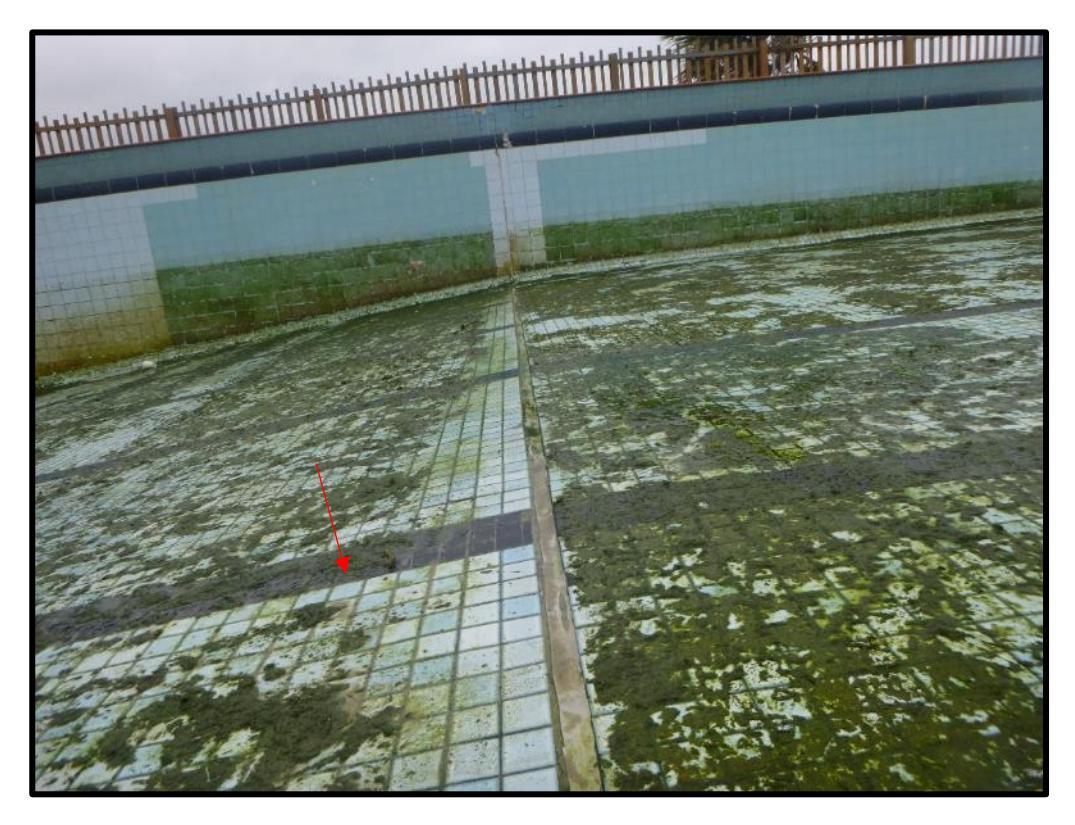
Photograph 44 – Water could be seen entering into the pool through both construction joints.

- 4.3 Significant work is required in order to retrofit sufficient waterproofing into the pool. Typically, this includes installing a new hydrophilic water stop and a 'bandage' such as Mapei 'Mapeband' along each construction joint. Cracks and joints in the pool shell are often injected using a permanently flexible low viscosity resin such as Tampur 150 however this can only be done whilst retiling the pool.
